Guaranteed Property Inspection, Inc.
26 Arcade
Irvine, CA 92603
(888) 252-2274

Prepared For: Mr. and Mrs. Home Buyer
Inspector: Steve Zivolich

Report #: Sample
Schedule Date: 8/24/2010

123 Main St.
Irvine, CA

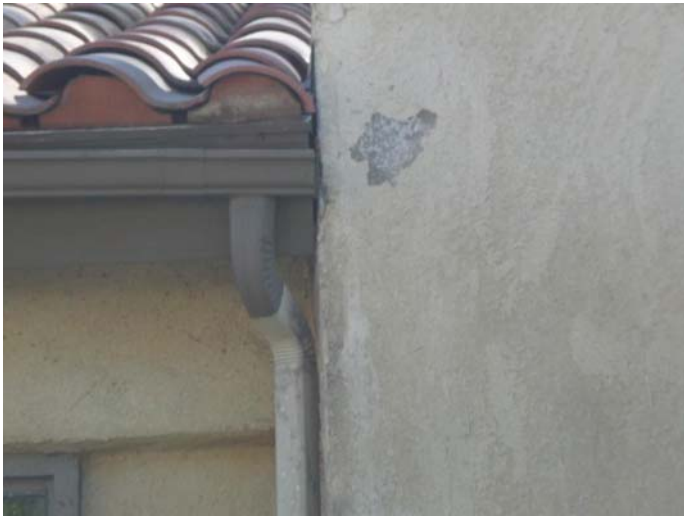
Stucco deterioration.

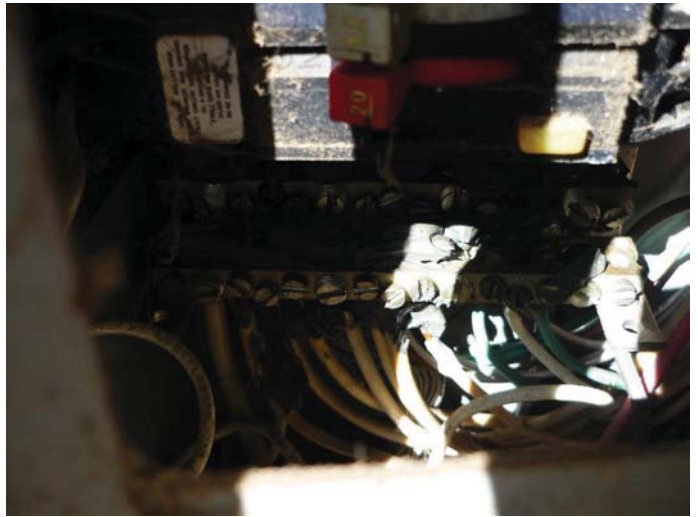
Aluminum wiring at 120 breakers, this condition can result in a fire hazard; recommend further evaluation of panel, and interior outlet/switch connections by a licensed electrician for correction with current recommended safety upgrades.

Paste at aluminum wiring at panel.

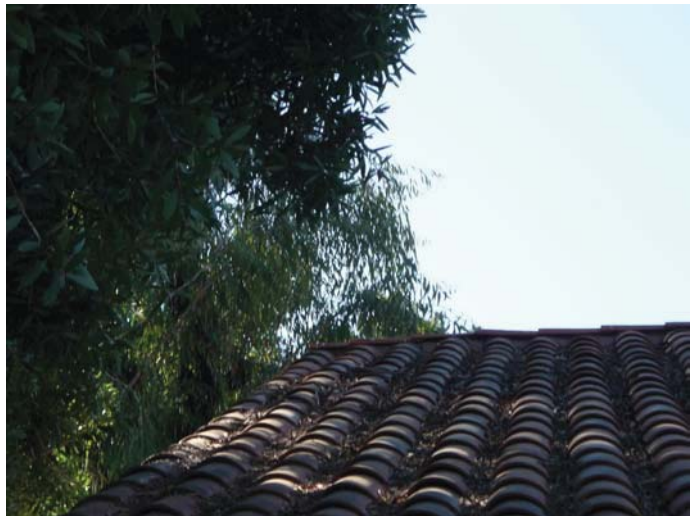
Neighbor trees are too close to structure and foundation, and are over the structures roof this condition can result in foundation or structure damage as well as roof drainage defects and entrance for rodent access that is not readily visible; recommend moving at least 4 feet away from the foundation and trimming trees so they are not over roof.

Debris on roof from neighbor trees, trees over roof.

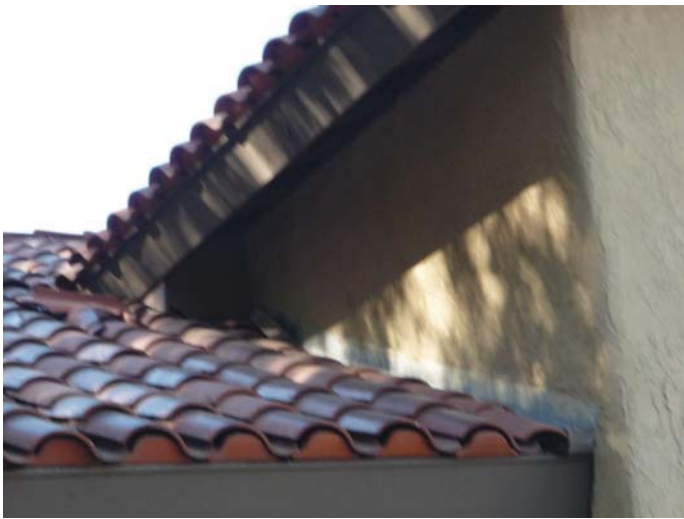
Moisture barrier paper was installed short, this condition can result in moisture damage at the roof edges; recommend further evaluation of the roofing system and corrections by a licensed roofer. Cracked tiles, recommend repair and further evaluation of roofing system by a licensed roofer. Displaced or missing tiles, recommend repairs and further evaluation of the roofing system by a licensed roofer. Mud deterioration at various areas; recommend correction.

Broken and displaced tiles.

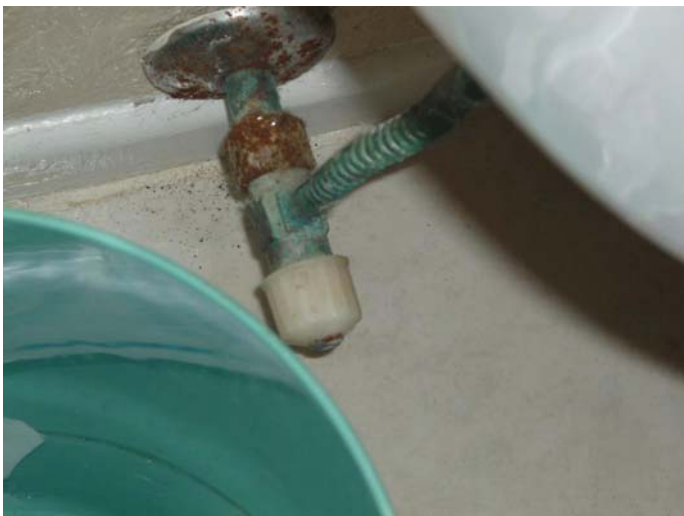
Corrosion at toilet valves.

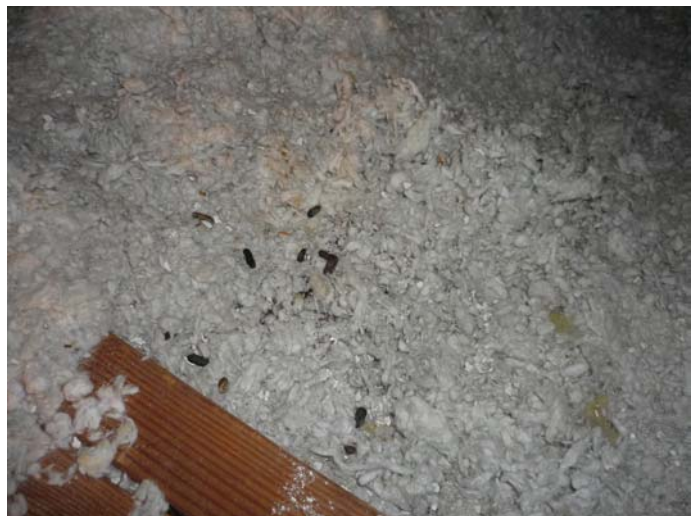
Rodent droppings attic.

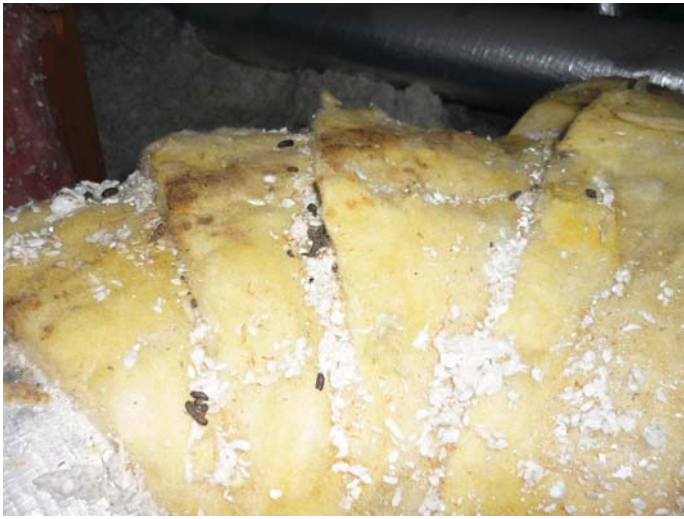
Rodent droppings attic.

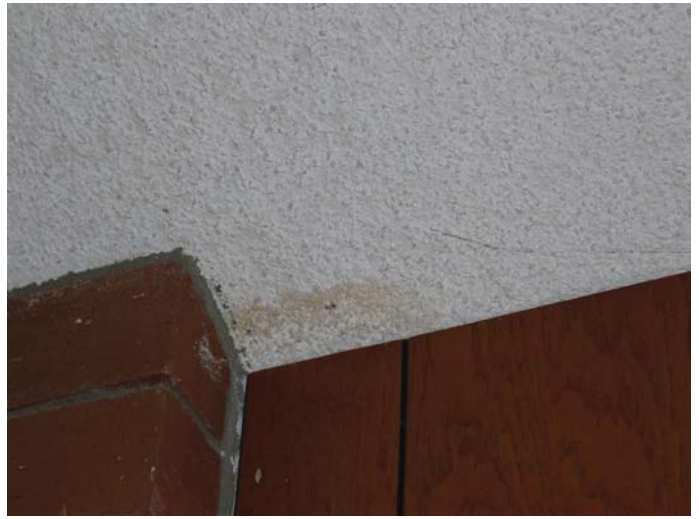
Ceiling stains at fireplace.

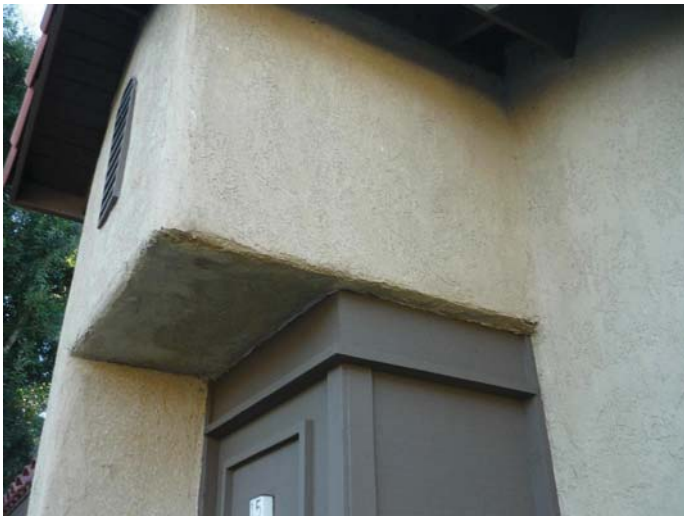
Stucco repair.

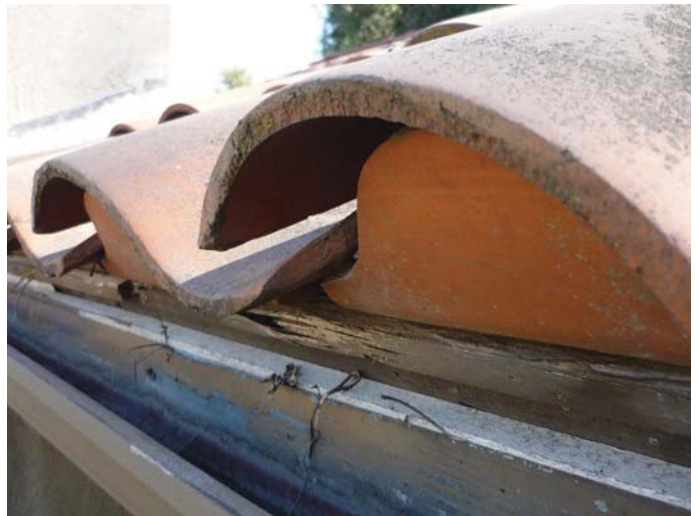
Edge flashing are not installed; this condition can result in moisture damage to the roof edge and eaves system; recommend installation by a licensed roofer.

Short paper with missing edge flashing and moisture damage.

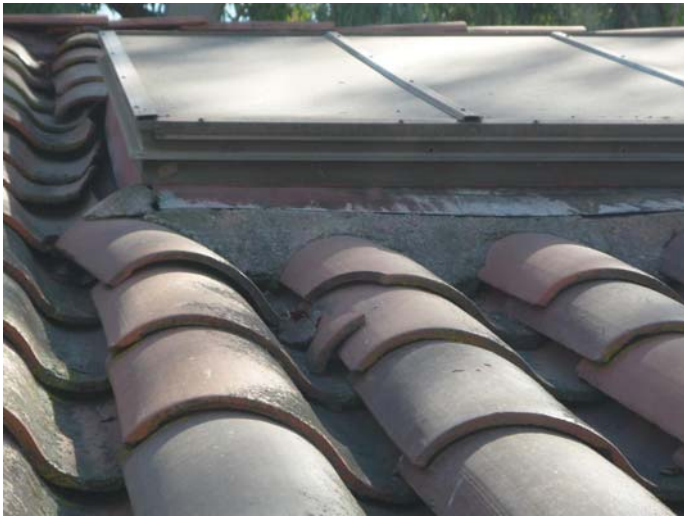
Cracked mud at skylight, cracked tiles.

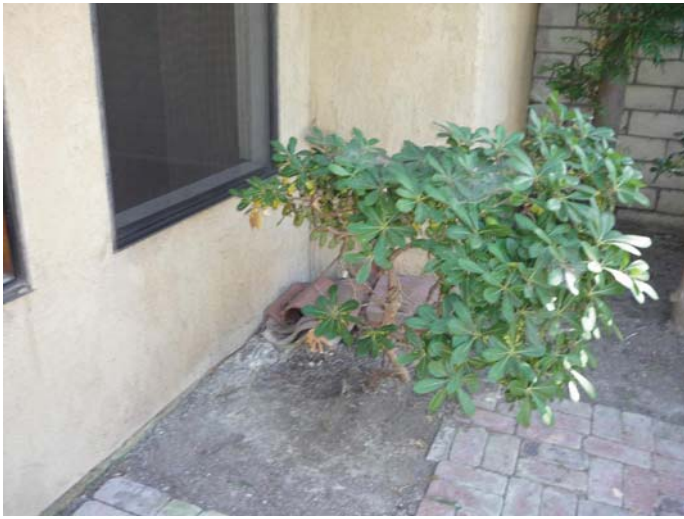
Inadequate separation from stucco weep screed at rear yard area, this condition can result in moisture intrusion to the interior that is not readily visible; recommend soil separation of 4-6" and or 2" for hardscape.

Soil too high at rear yard.

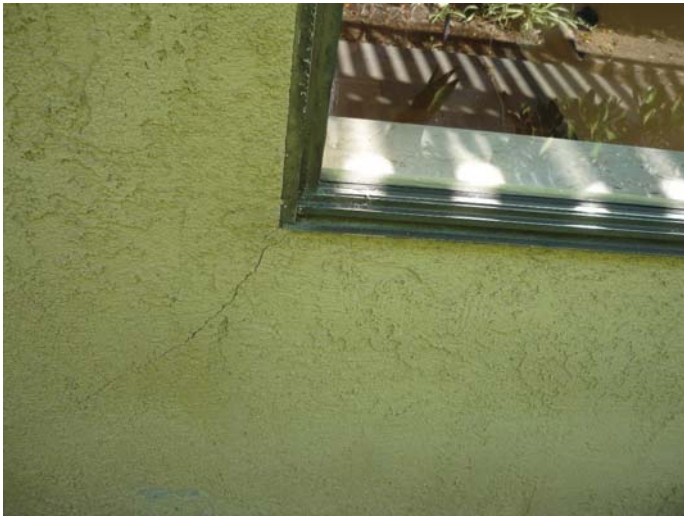
Stucco crack.

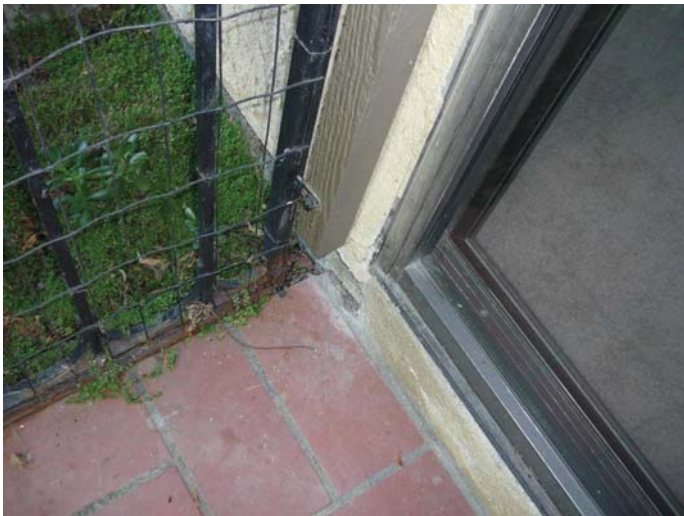
Gate deterioration, recommend adjustment and repair. Fence damage, recommend repairs.

Fence damage.

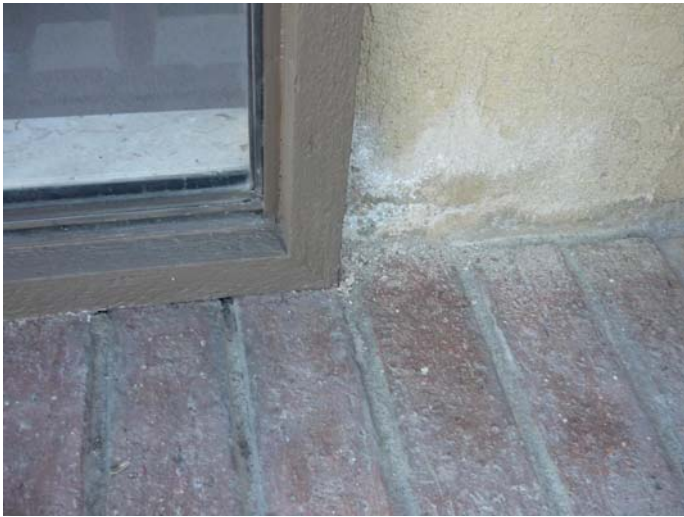
Stucco deterioration.

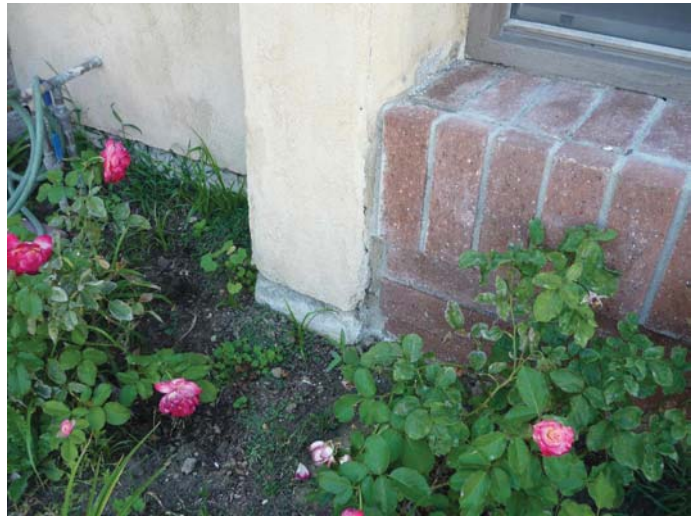
Stucco deterioration.

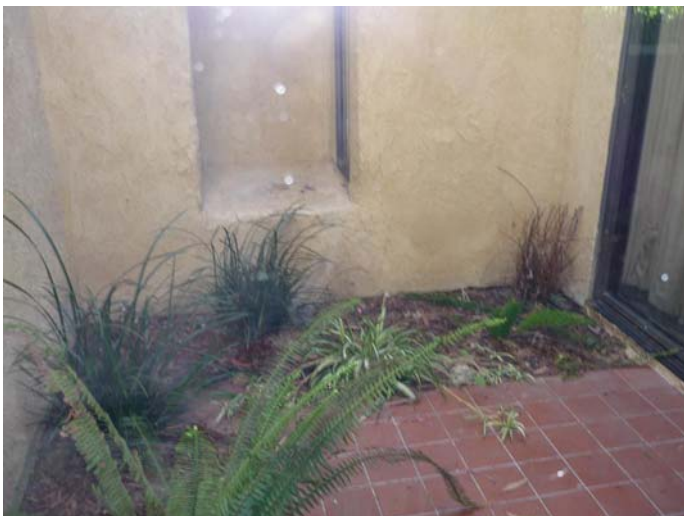
Uneven transition from walkway, recommend correction. Soil too high at mid patio, drain system was not located; recommend further evaluation and correction.

Soil too high to weep screen interior patio, drain not located.

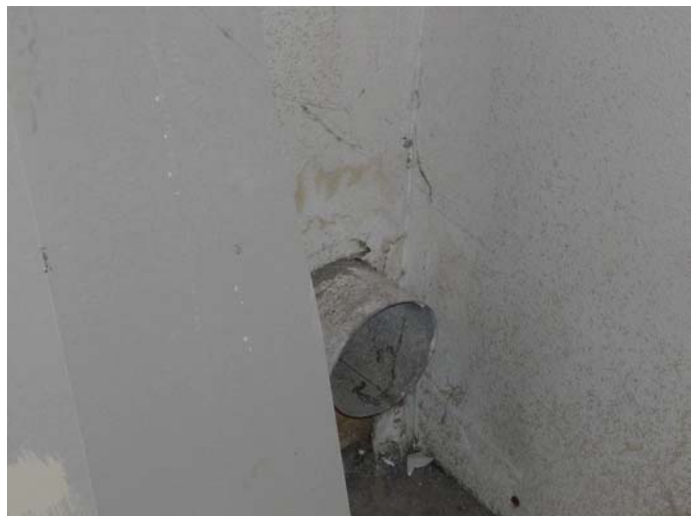
Moisture stains, recommend further evaluation by a licensed plumber for moisture source and correction. Mold testing of the area is recommended.

Moisture stains garage wall.

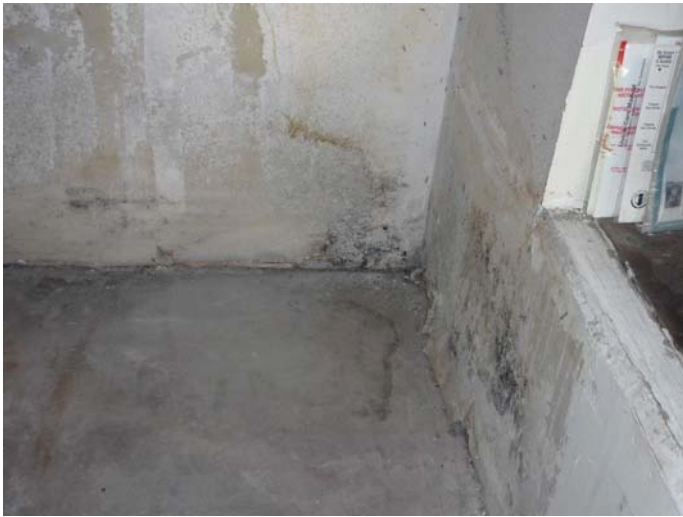
Moisture stain/damage, this is an indication of current or historical water heater or system leakage, recommend further evaluation and corrections of water heater and or related plumbing by a licensed plumber; and mold testing of area.

Moisture stains and probable mold growth laundry and water heater area.

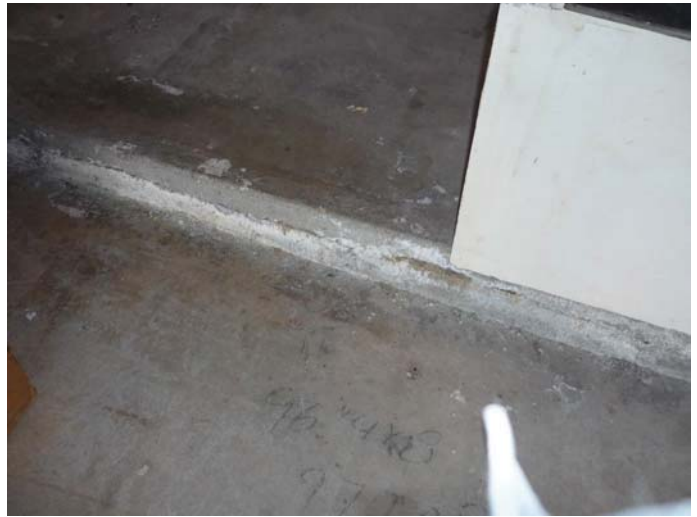
Efflorescence at foundation, recommend correction of moisture source to prevent moisture damage to foundation. Cold pour crack with efflorescence near laundry area, recommend further evaluation.

Cold pour crack with efflorescence garage.

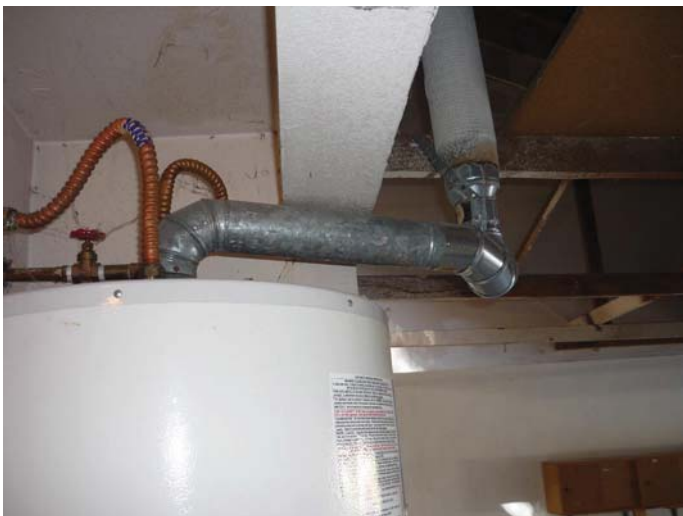
Lacks proper separation from combustible, with negative slope recommend correction.

Vent negative slope and touching combustible.

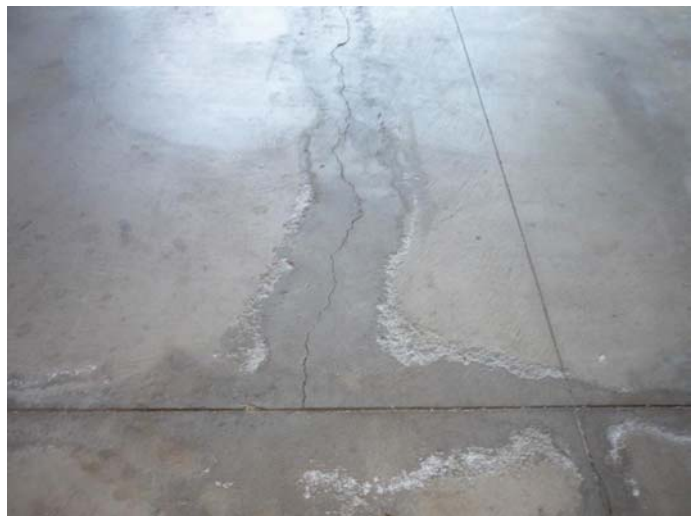
Garage slab crack.

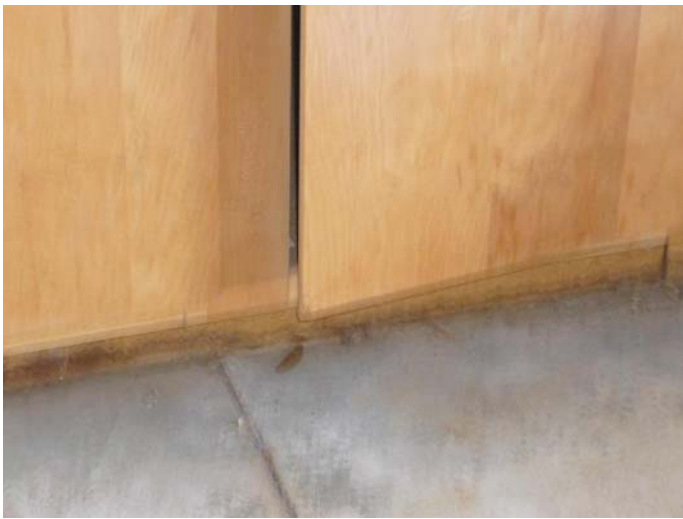
Major cracks, moisture stains at cabinet base, recommend further evaluation by a licensed contractor.

Moisture stains at garage cabinet base.

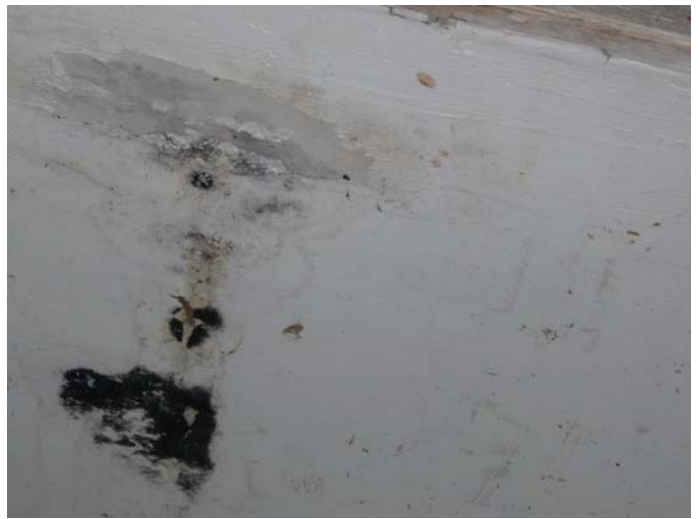
Probable mold and moisture stains at exterior, recommend mold testing.

Probable mold growth HVAC platform.

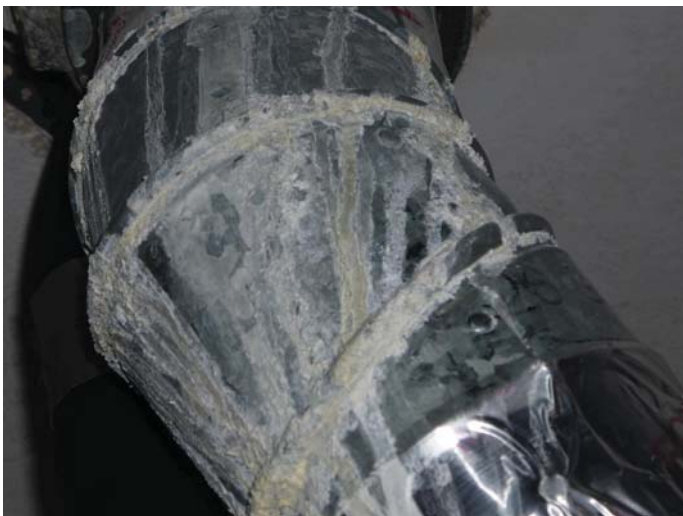
Corrosion at vent, this may be an indication of leakage, and or poor ventilation performance, recommend further evaluation by an HVAC contractor.

Corrosion heater vent.

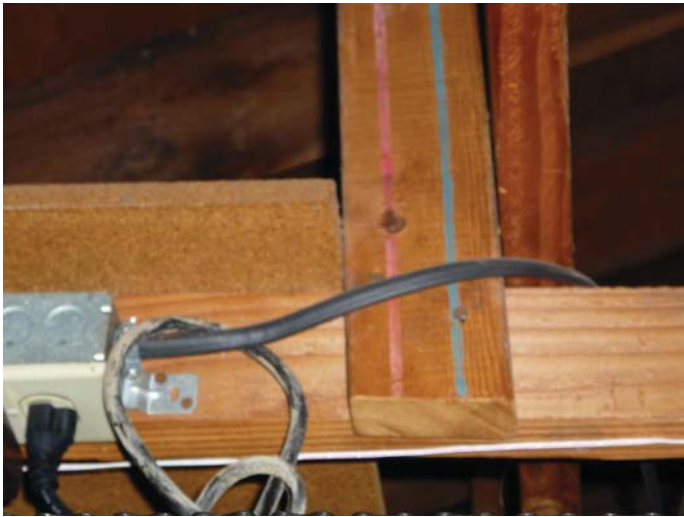
GFCI was not located; recommend adding for enhanced safety. Improper visible romex wiring, recommend correction.

Improper garage conduit.

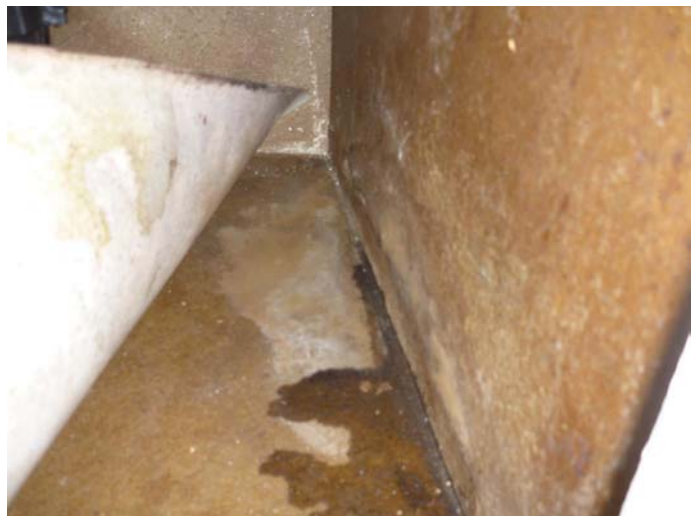
156. Cabinets/Drawers	HAZARDOUS	Moisture damage under sink. Moisture stains under sink.
<p>Child safety latch not present. Cabinet stains/damage. Worn.</p> <p>Moisture damage, this may be an indication of further damage and mold growth that is not readily visible; recommend mold testing and repairs. Cabinet stains/damage, recommend servicing and mold testing. Moisture stains under sink area, this may be an indication of mold growth and damage that is not readily visible; recommend mold testing of area. Worn, heavy use, recommend servicing. Child safety latch is not present for cabinet under sink, recommend installation if children will be present to prevent poisoning hazards.</p>

Moisture, damage and probable mold growth under kitchen sink.

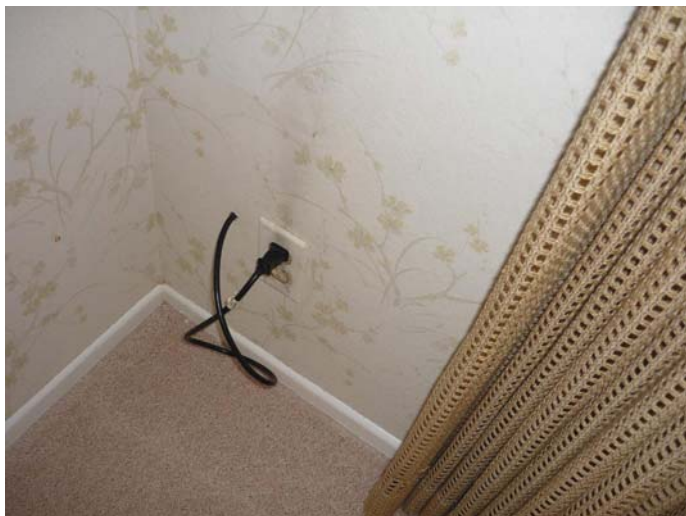
Improper wiring dining.

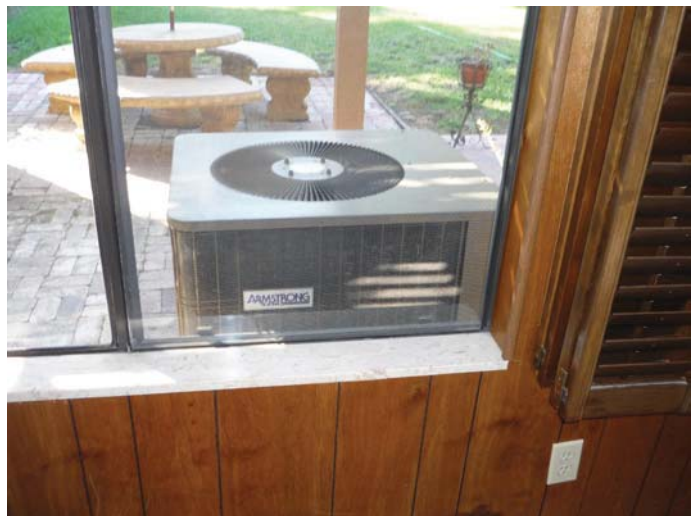
Poor AC location.
