Inspection Report

Sample Report

Property Address: 456 Main St. Irvine CA

Date: 11/21/2019	Time: 10:00 AM	Report ID: MainStlrvine
Property: 456 Main St. Irvine CA	Customer: Sample Report	Real Estate Professional:

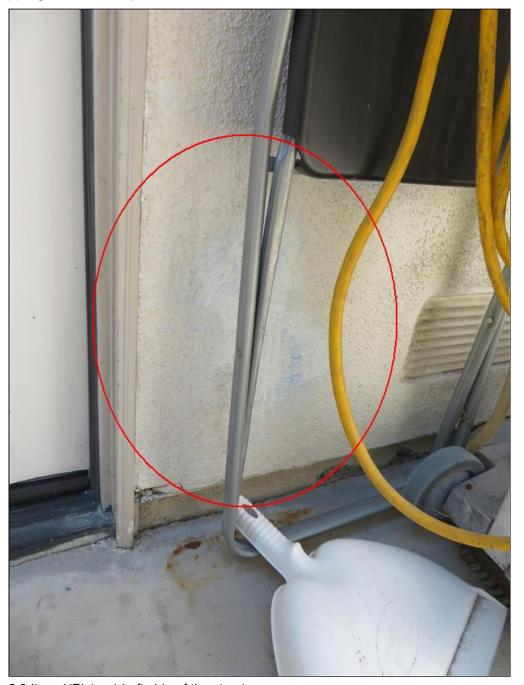
2.0 Item 1(Picture) Left side of the structure.

(1) Signs of stucco repairs observed at the left side of the structure; we recommend further inquiry of the seller.

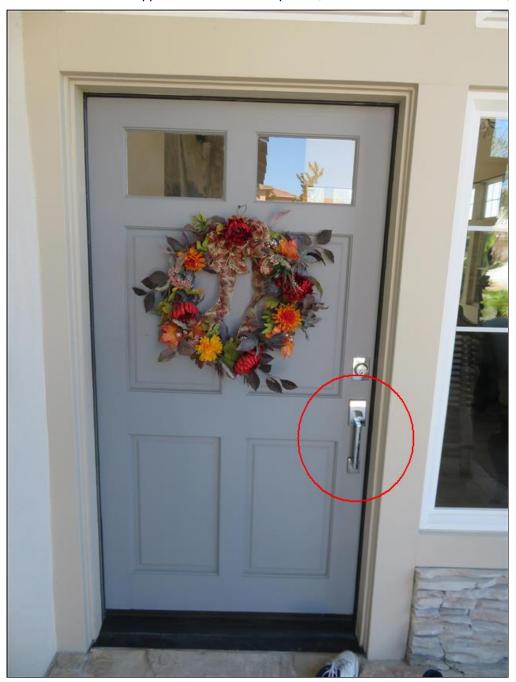
2.1 Item 1(Picture) Front door.

The front door handle appears to have been replaced; cracks exist around the handle; we recommend repairs.

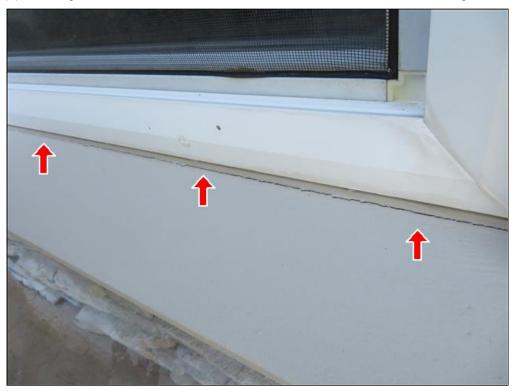
2.2 Item 4(Picture) Front of the structure.

(2) Caulking deterioration at the front of the structure, we recommend servicing.

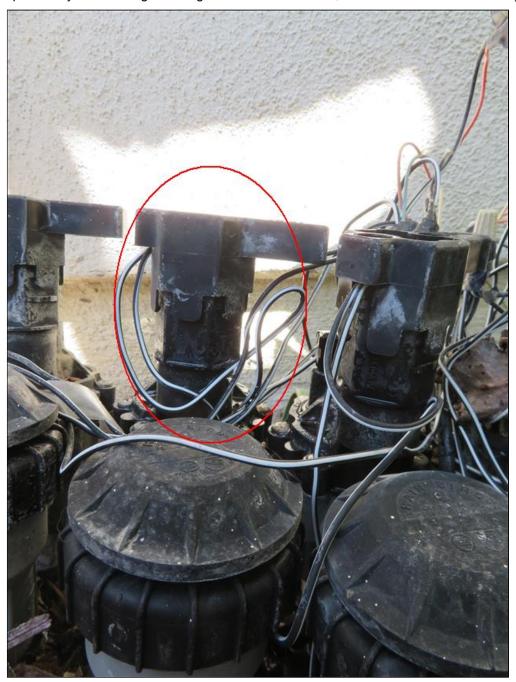
2.12 Item 1(Picture) Right side of the structure.

Sprinkler system leaking at the right side of the structure; we recommend corrections by a plumber.

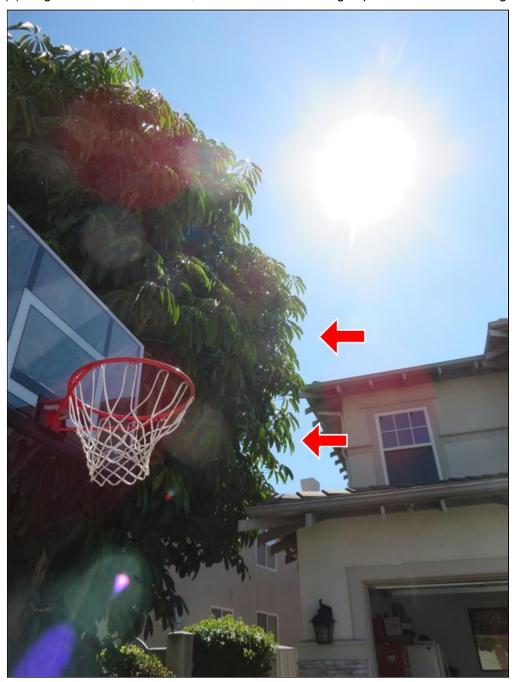
2.15 Item 1(Picture) Roof.

(1) Neighbor tree over roof area, we recommend trimming to protect the roof coverings.

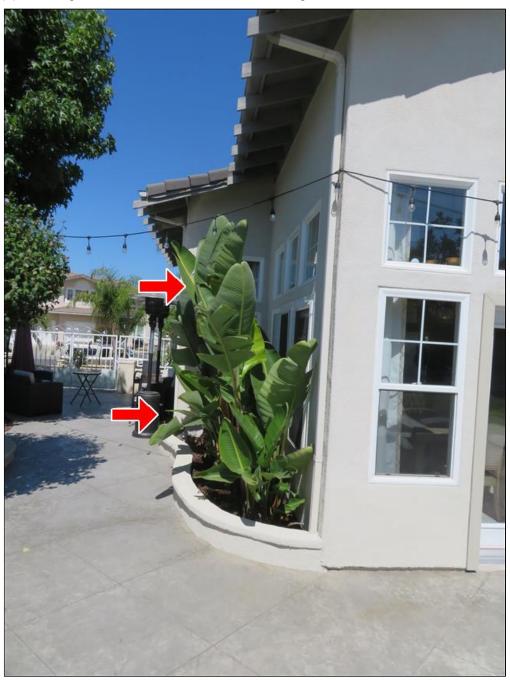
2.15 Item 2(Picture) Right side of the structure.

(2) Touching the structure, we recommend trimming.

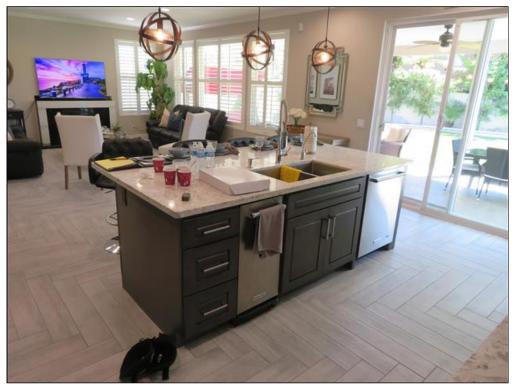
3.9 Item 1(Picture) Kitchen island.

We recommend that all outlets within 6' of wet areas be upgraded to GFCI for enhanced safety.

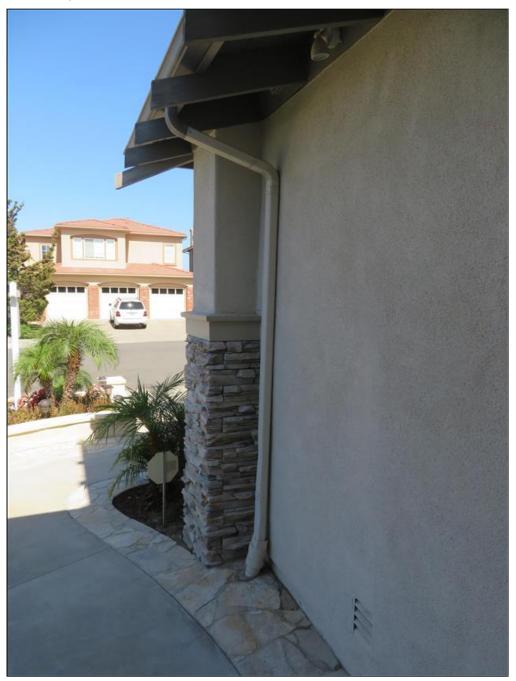
4.4 Item 1(Picture) Front of the structure.

The downspout at the front of the structure is not mounted to the wall; we recommend repairs.

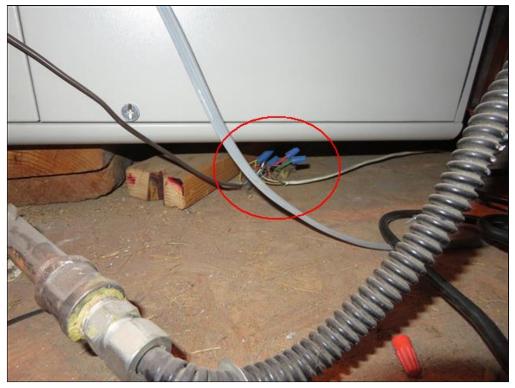
4.10 Item 1(Picture) Attic.

Exposed splices, we recommend a complete evaluation of the electrical system in the attic since this is an indication that work was not completed by a licensed electrician; this is a safety hazard.

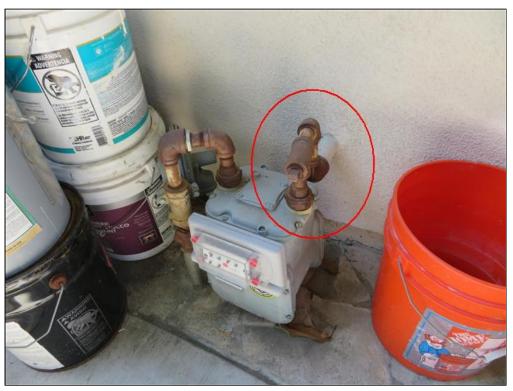
5.6 Item 1(Picture) Gas meter.

Gas meter lacks seismic shut off device, we recommend installation for enhanced safety.

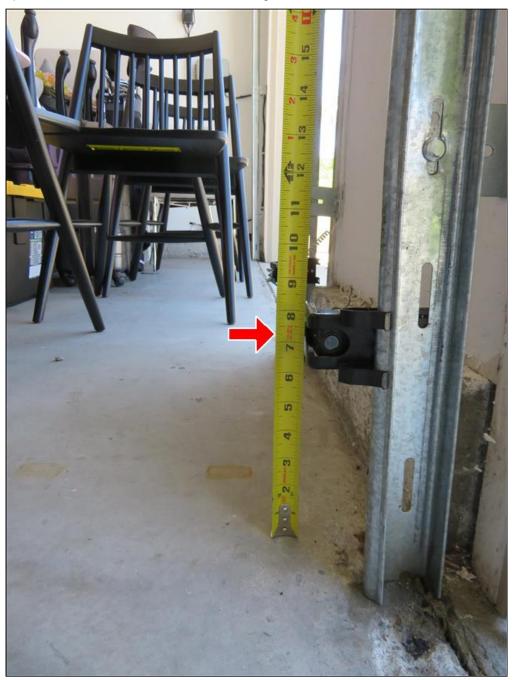
6.5 Item 1(Picture) Garage.

Optical sensors are more than 6" above the ground, recommend corrections for child and pet safety.

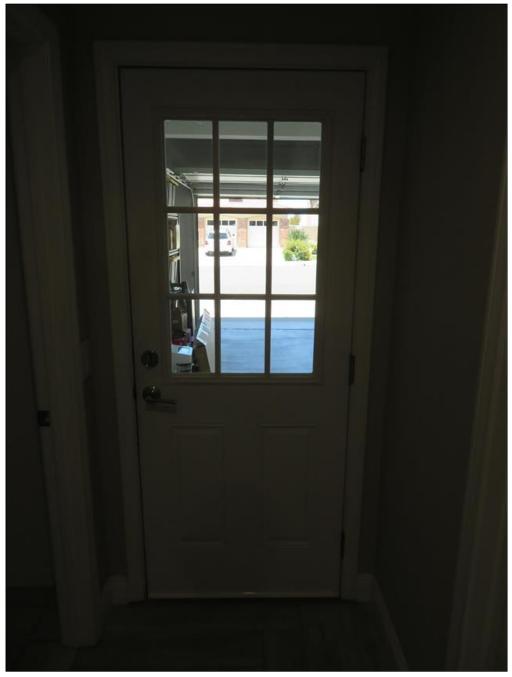
6.6 Item 1(Picture) Garage door.

The occupant door from inside garage to inside the home is not a fire rated door. This means that should a fire occur in garage, the occupant door does not afford protection until fireman arrive. This door should be replaced with a fire rated door.

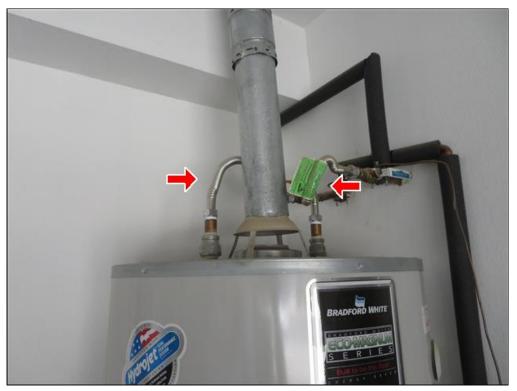
8.2 Item 1(Picture) Water heater.

Hot and cold water lines are missing R-4 insulation, we recommend installation for energy savings.

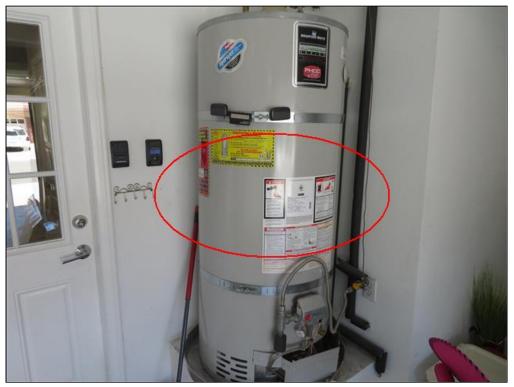
8.6 Item 1(Picture) Water heater.

52+ size water heater requires a third seismic strap at mid-line, we recommend installation to meet CA seismic guidelines.

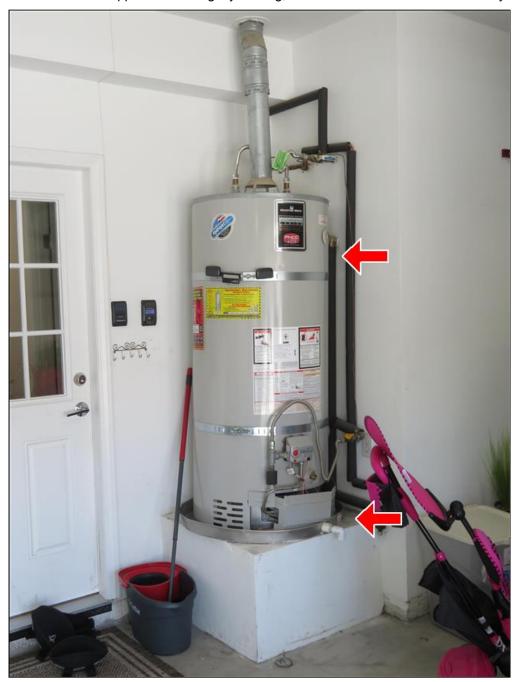
8.7 Item 1(Picture) Water heater.

The water heater appears to be slightly leaning; we recommend further evaluation by a licensed plumber.

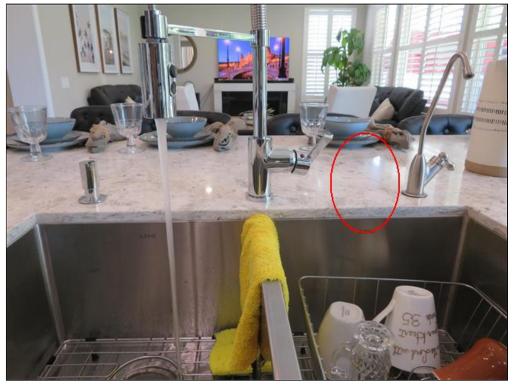
9.12 Item 1(Picture) Air gap.

Not installed, this can result in waste water mixing into the clean cycle; note that a few models have an internal air gap (which is not common); recommend installation for water quality safety.

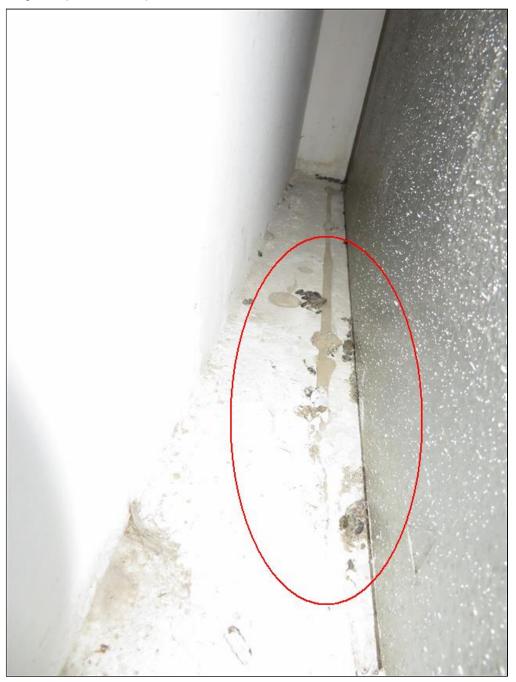
10.6 Item 1(Picture) HVAC enclosure.

Possible rodent droppings observed at the HVAC enclosure; we recommend further evaluation and cleanup by a integrated pest control specialist.

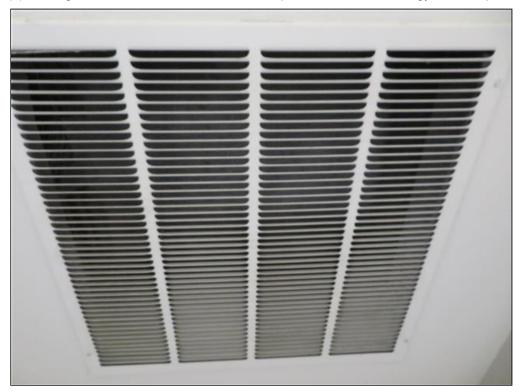
10.10 Item 1(Picture) Lower hallway.

(1) Missing at the air return; we recommend replacement with an allergy rated disposable filter.

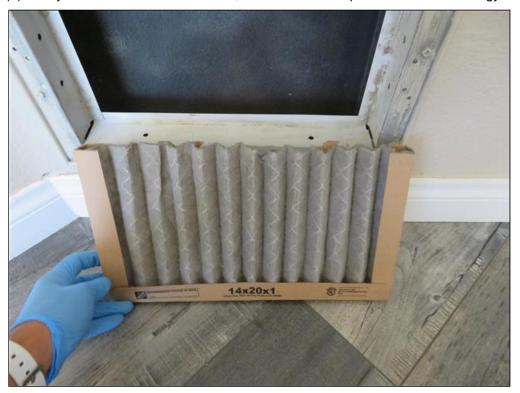
10.10 Item 2(Picture) Master bedroom.

(2) Poorly sized at the master bedroom, we recommend replacement with an allergy rated disposable filter.

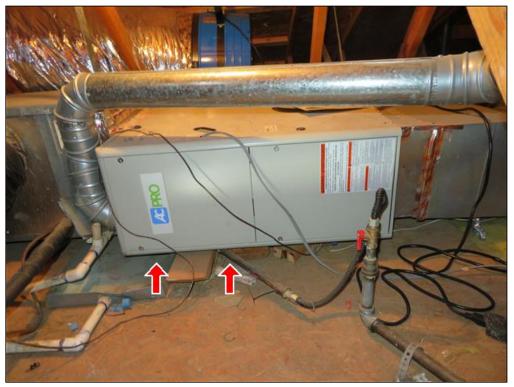
10.12 Item 2(Picture) HVAC.

(2) The HVAC system located in the attic appeared to be mounted improperly; the system was resting on wood piers; we recommend correction by an HVAC contractor.

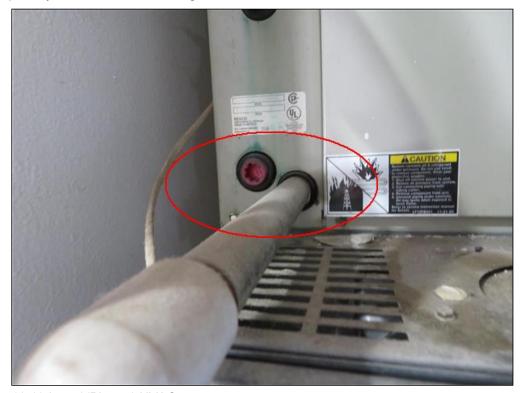
10.13 Item 2(Picture) HVAC.

(3) A secondary drain line or auto disconnect device was not installed; these should be installed if blockage in the primary line could cause damage to the structure.

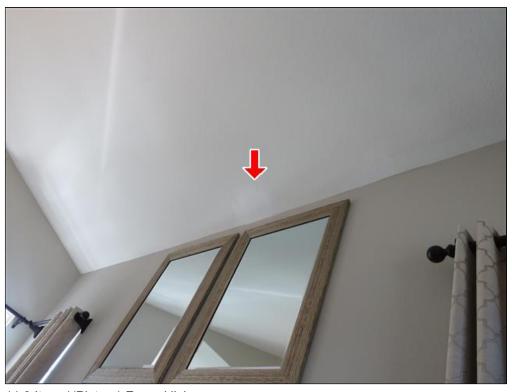
11.0 Item 1(Picture) Formal living room.

Signs of repairs noticed at the formal living room ceiling and kitchen ceiling; we recommend further inquiry of the seller.

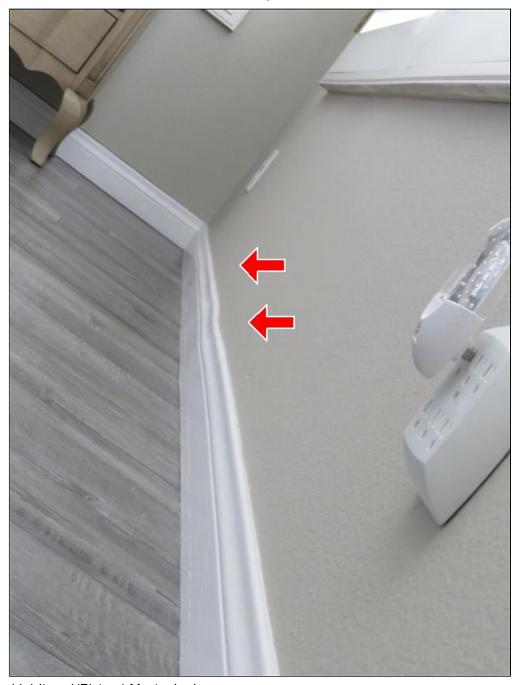
11.1 Item 1(Picture) Master bedroom.

(1) Signs of warping at the master bedroom wall beneath the windows; this can be due to moisture intrusion from the exterior; we recommend further evaluation by a licensed contractor.

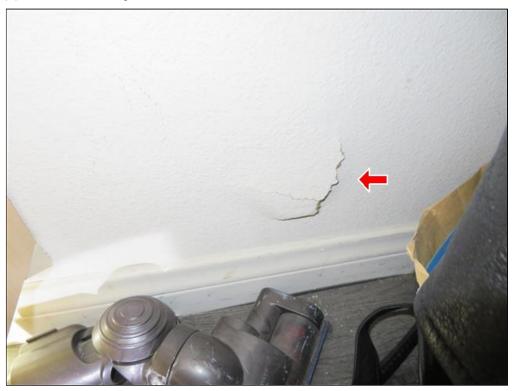
11.1 Item 3(Picture) Master bedroom.

(2) There was damaged observed at the master bedroom closet lower wall; we recommend repairs.

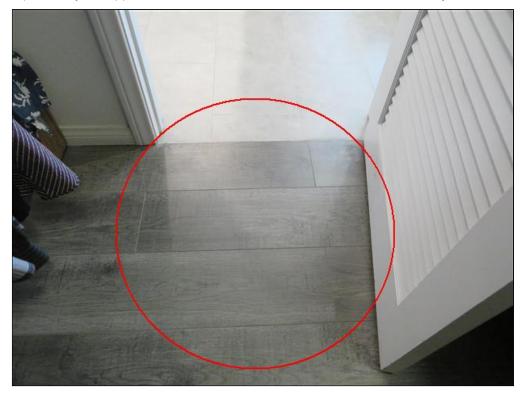
11.2 Item 1(Picture) Master bedroom closet.

(1) Floor noise at upper level master bedroom closet, this is not atypical for older homes, however it can be an indication of poor installation practices and defects, we recommend further evaluation. These conditions can often be improved by the application of additional screws in the floor boards at the joists.

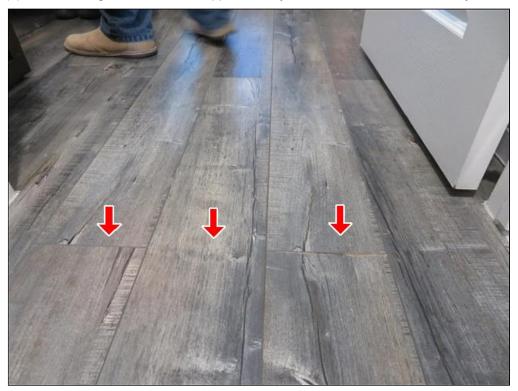
11.2 Item 2(Picture) Upper hallway flooring.

(2) Lifted flooring observed at the upper hallway; we recommend corrections by a licensed contractor.

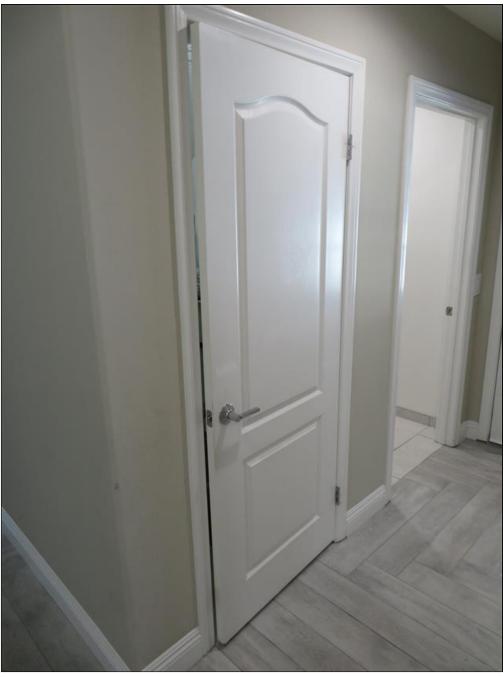
11.4 Item 1(Picture) Hallway.

(1) Rubbed at frame at the hallway closet, we recommend correction by a qualified professional.

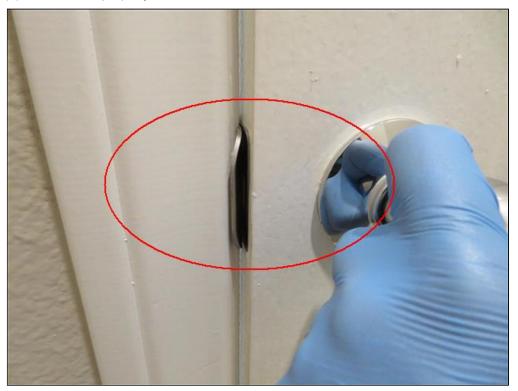
11.4 Item 3(Picture) Master bathroom.

(2) Did not latch properly at the master bathroom toilet, we recommend correction.

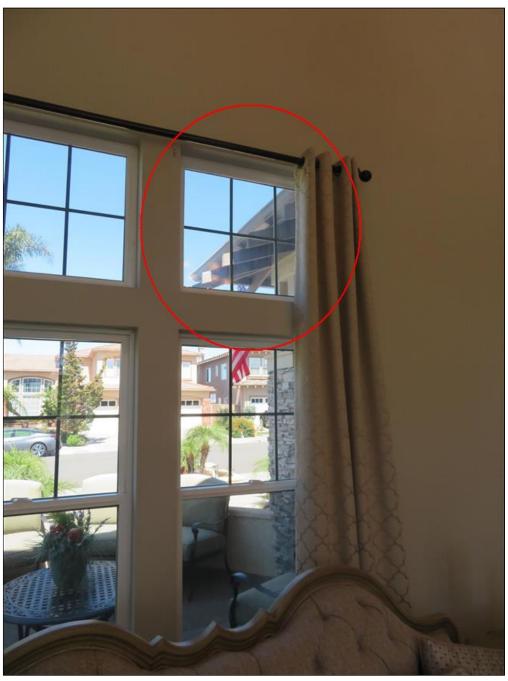
11.5 Item 1(Picture) Formal living room.

(1) Fogged windows indicate a failure of the energy efficiency of the window system; we recommend replacement. We identify all fogged windows that are readily visible during our inspection; however due to owner property and lighting conditions we may not be able to identify all defective conditions. Several window makers have extended warranties on failed window sills; we recommend further inquiry.

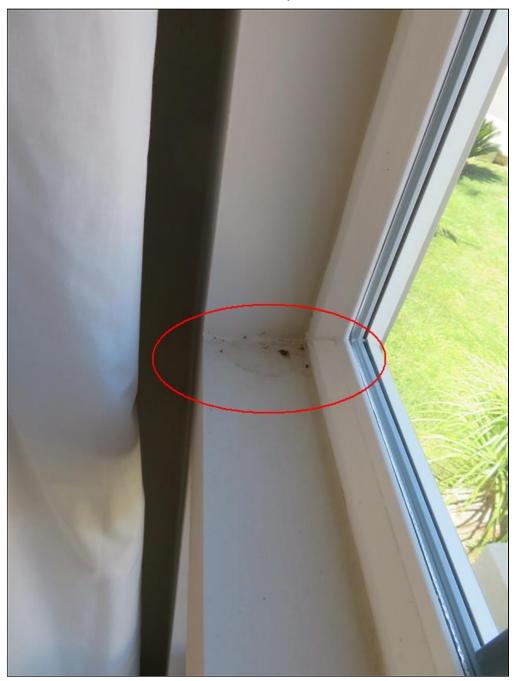
11.5 Item 5(Picture) Formal living room.

(2) Moisture staining observed at the formal living room window sill; this indicates a possible defective sill; we recommend further evaluation and corrections by a licensed window contractor.

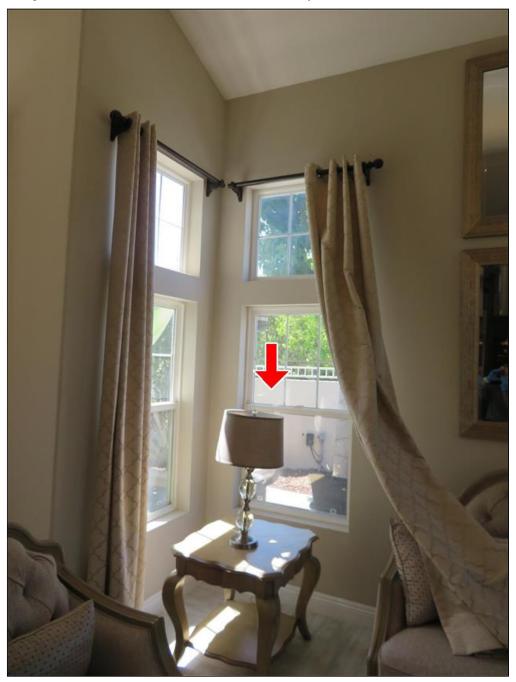
11.5 Item 7(Picture) Formal living room.

(3) Broken sash is a defect when a window will not remain in the open position, and can result in the window free falling to the sill; we recommend correction for safety.

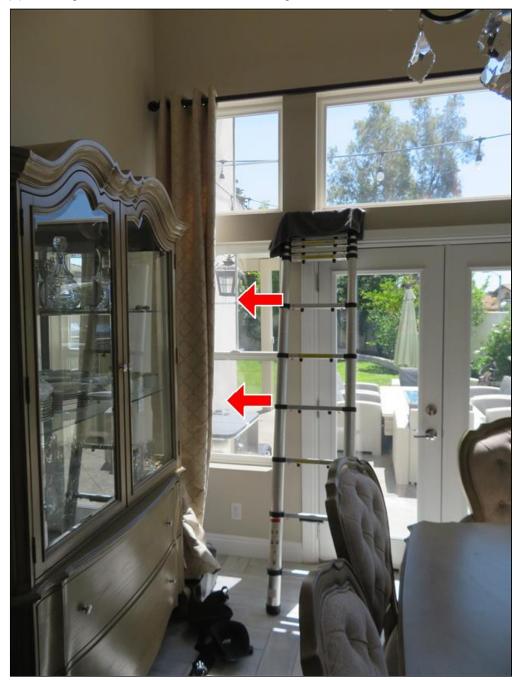
11.5 Item 9(Picture) Dining room.

(4) Caulking deterioration observed at the dining room window; we recommend servicing.

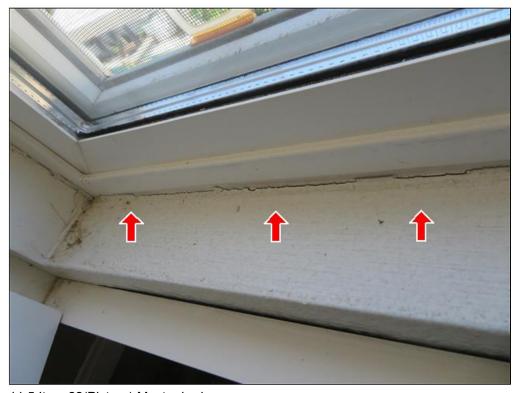
11.5 Item 22(Picture) Master bedroom.

(5) Moisture intrusion at sills at the family room and master bedroom, this is an indication of leakage, we recommend leak testing of the windows and repairs as needed by a licensed window contractor.

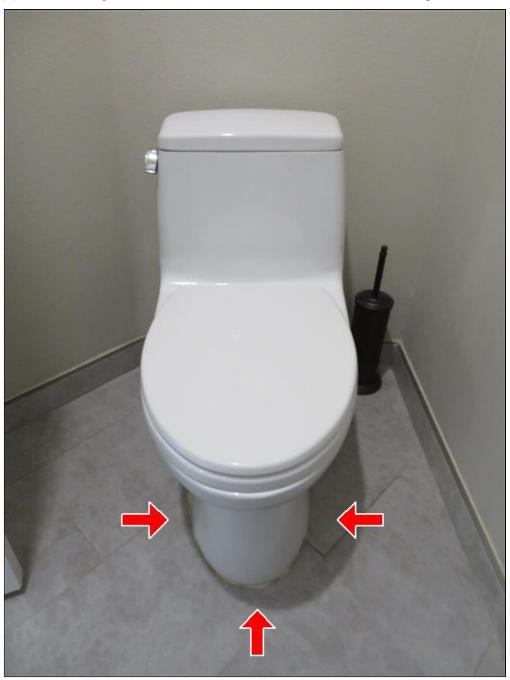
12.6 Item 1(Picture) Master bathroom.

(2) Lacks caulking: at the master bathroom; we recommend servicing.

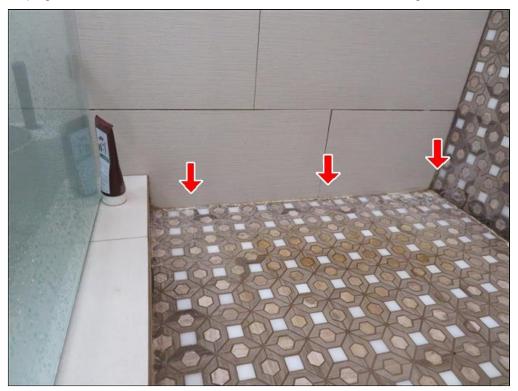
12.8 Item 1(Picture) Upper hallway bathroom.

Caulking deterioration observed at the upper hallway bathroom shower enclosure; this condition can result in water seeping between the shower surface and liner and can result in mold growth; we recommend re-caulking.

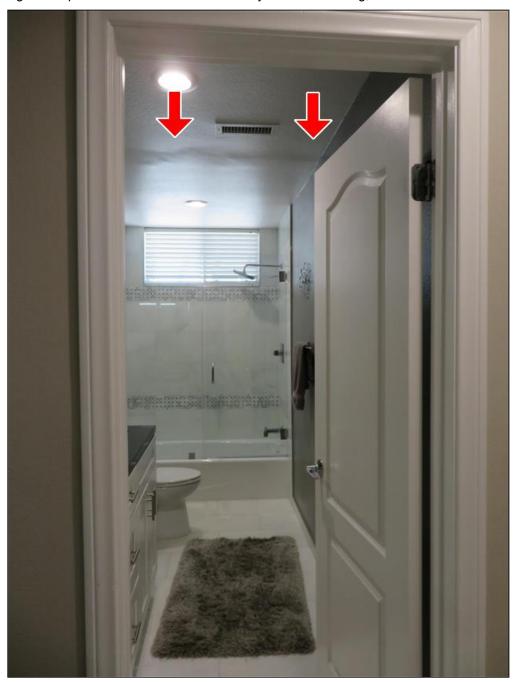
12.12 Item 1(Picture) Lower hallway bathroom.

Signs of repairs noticed at the lower hallway bathroom ceiling; we recommend further inquiry of the seller.

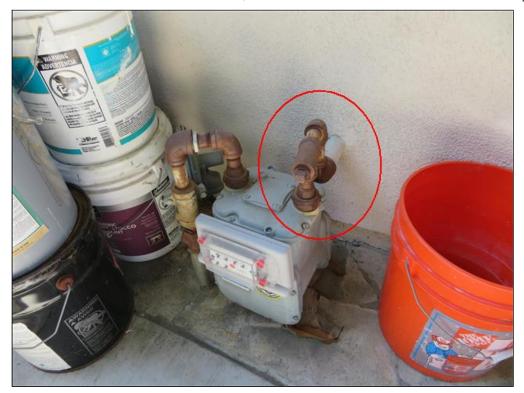
5.6 Item 1(Picture) Gas meter.

Gas meter lacks seismic shut off device, we recommend installation for enhanced safety.

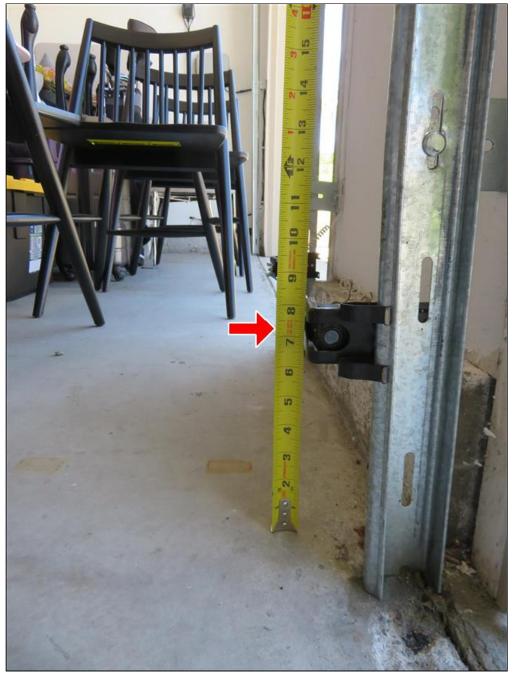
6.5 Item 1(Picture) Garage.

Optical sensors are more than 6" above the ground, recommend corrections for child and pet safety.

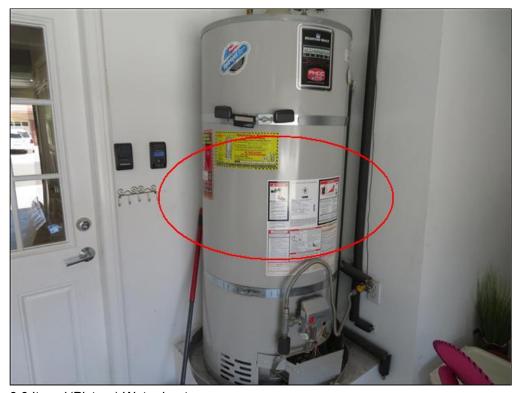
8.6 Item 1(Picture) Water heater.

52+ size water heater requires a third seismic strap at mid-line, we recommend installation to meet CA seismic guidelines.

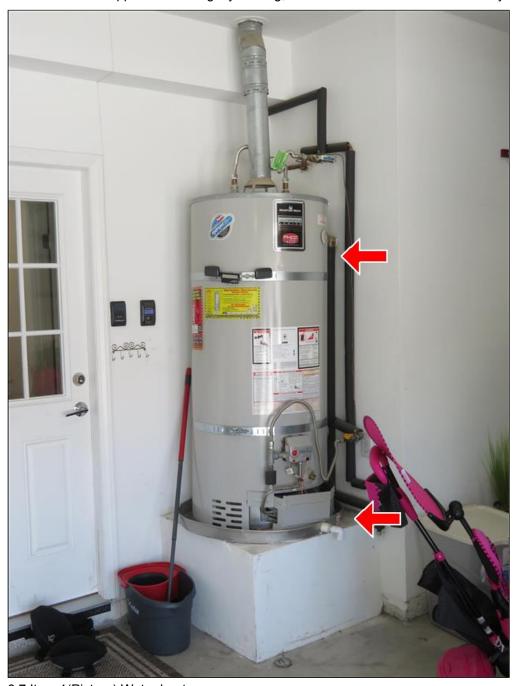
8.7 Item 1(Picture) Water heater.

The water heater appears to be slightly leaning; we recommend further evaluation by a licensed plumber.

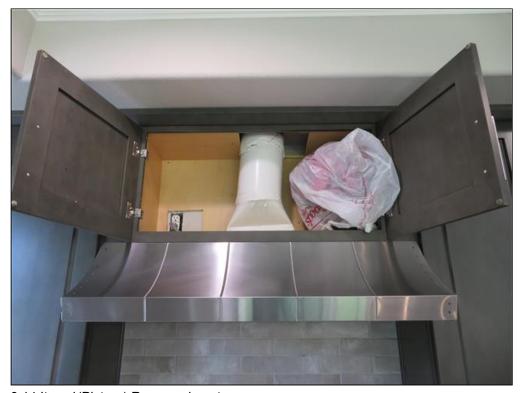
9.14 Item 1(Picture) Range exhaust.

(1) Disconnected at the exhaust, we recommend correction by securing with 3 metal sheet screws at each end and sealing with aluminum tape.

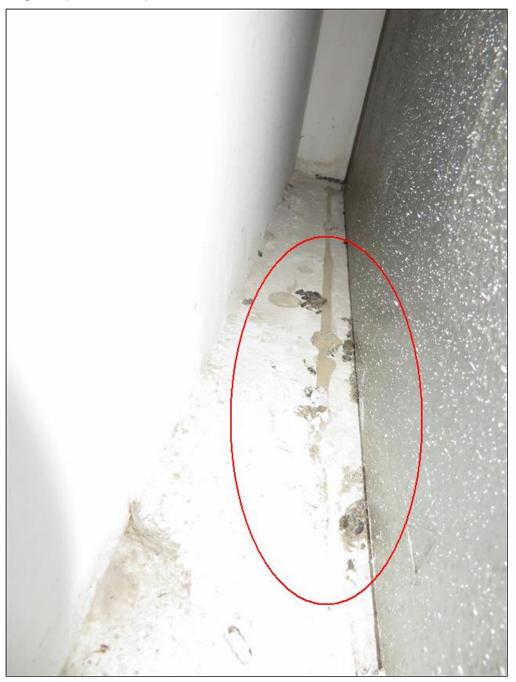
10.6 Item 1(Picture) HVAC enclosure.

Possible rodent droppings observed at the HVAC enclosure; we recommend further evaluation and cleanup by a integrated pest control specialist.

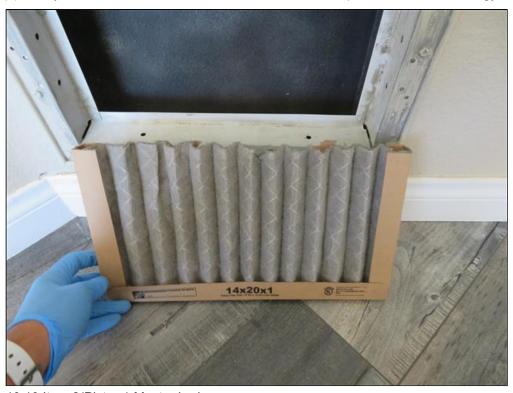
10.10 Item 2(Picture) Master bedroom.

(2) Poorly sized at the master bedroom, we recommend replacement with an allergy rated disposable filter.

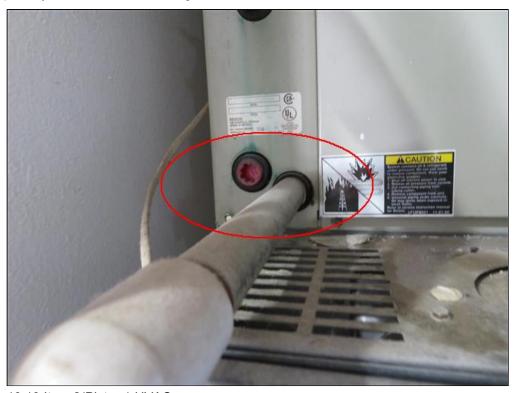
10.13 Item 2(Picture) HVAC.

(3) A secondary drain line or auto disconnect device was not installed; these should be installed if blockage in the primary line could cause damage to the structure.

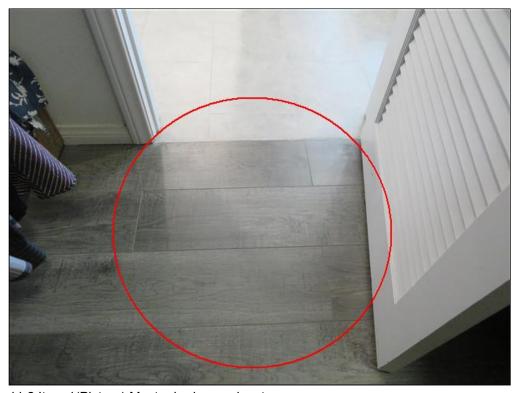
11.2 Item 1(Picture) Master bedroom closet.

(1) Floor noise at upper level master bedroom closet, this is not atypical for older homes, however it can be an indication of poor installation practices and defects, we recommend further evaluation. These conditions can often be improved by the application of additional screws in the floor boards at the joists.

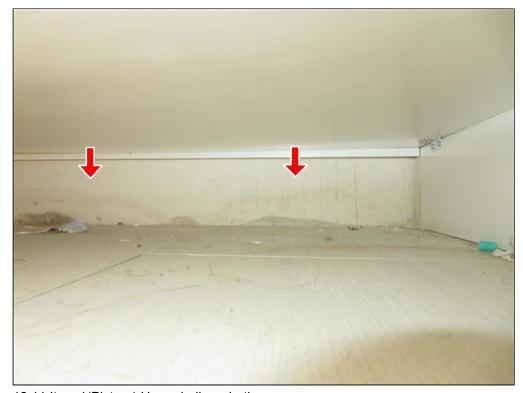
12.11 Item 1(Picture) Upper hallway bathroom.

There were moisture stains observed at the upper hallway bathroom wall behind the vanity; this can be due to a historic moisture event; we recommend further evaluation by a plumber to verify that the moisture source has been corrected.

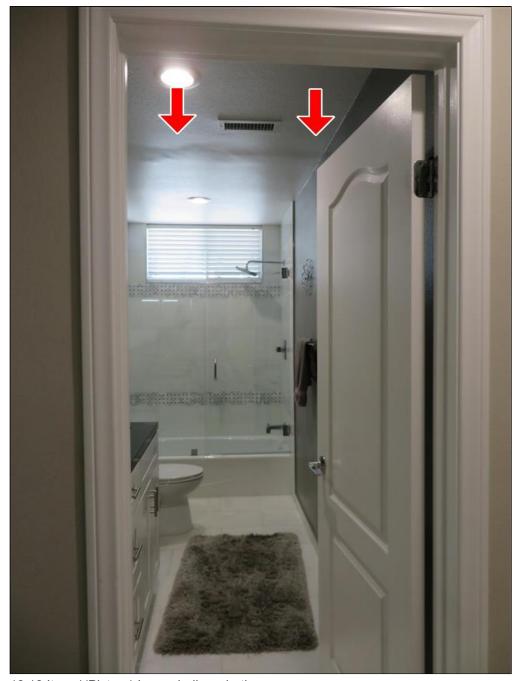
12.12 Item 1(Picture) Lower hallway bathroom.

Signs of repairs noticed at the lower hallway bathroom ceiling; we recommend further inquiry of the seller.
