Inspection Report

Sample Report

Property Address: 456 Main St. Irvine CA

Date: 11/21/2019	Time: 10:00 AM	Report ID: MainStlrvine
Property: 456 Main St. Irvine CA	Customer: Sample Report	Real Estate Professional:

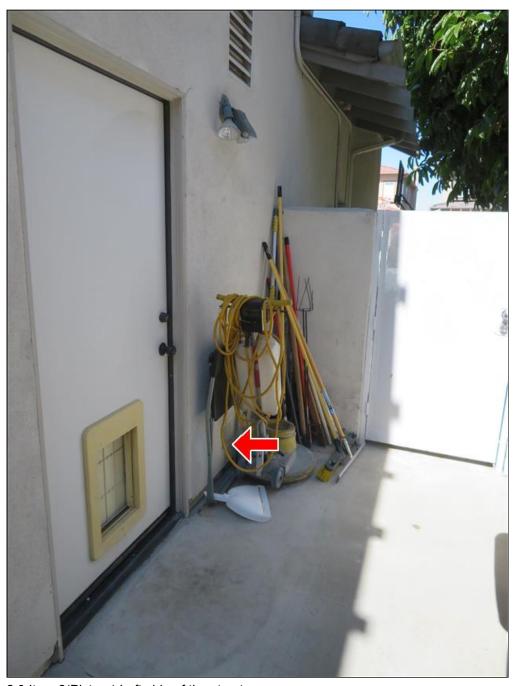
2.0 Item 2(Picture) Left side of the structure.

(1) Signs of stucco repairs observed at the left side of the structure; we recommend further inquiry of the seller.

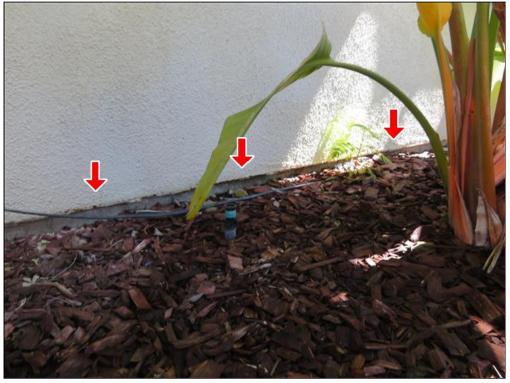
2.0 Item 3(Picture) Left side of the structure (planter)

(2) Poor weep screed clearance (2" above paving; 4" above soil); this condition results in corrosion, and unwanted moisture intrusion into the wall and interior that may not be readily visible.

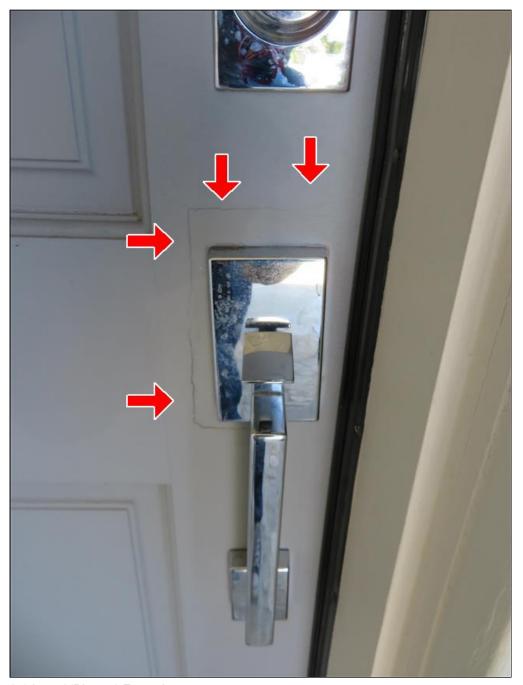
2.1 Item 2(Picture) Front door.

The front door handle appears to have been replaced; cracks exist around the handle; we recommend repairs.

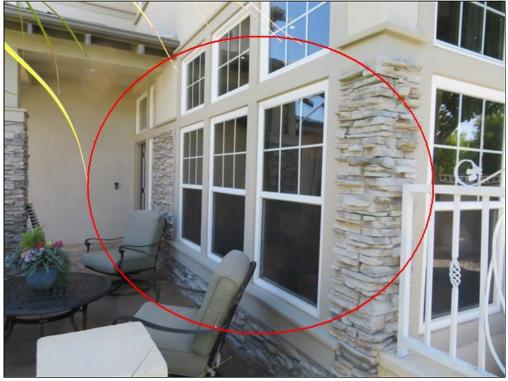
2.2 Item 1(Picture) Front of the structure.

(1) The wood trim at the exterior window front of the structure are moisture damaged; we recommend further evaluation and repairs by a termite professional.

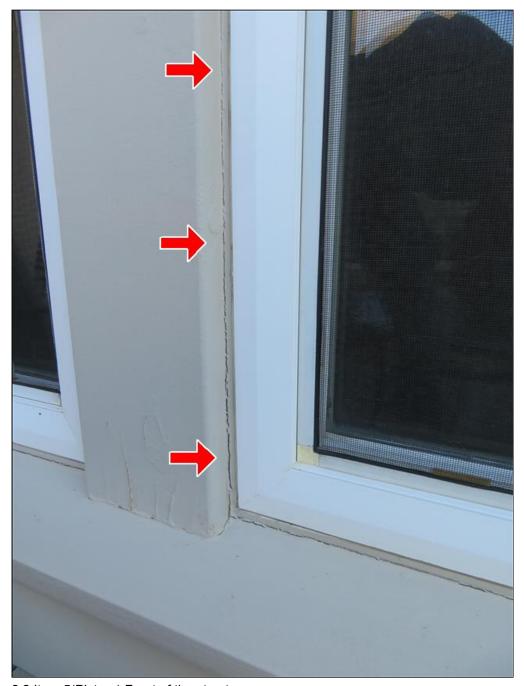
2.2 Item 5(Picture) Front of the structure.

(2) Caulking deterioration at the front of the structure, we recommend servicing.

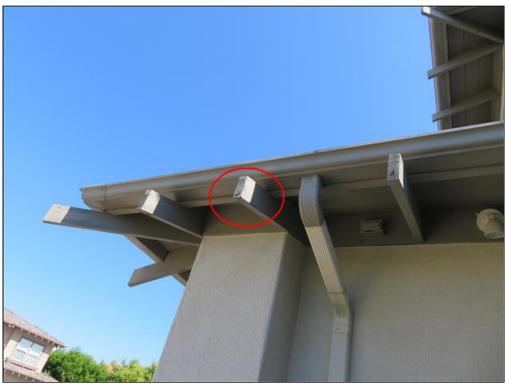
2.4 Item 1(Picture) Front of the structure.

Moisture damage; we recommend further evaluation by a termite professional, to determine the extent of moisture damage to the wood structure.

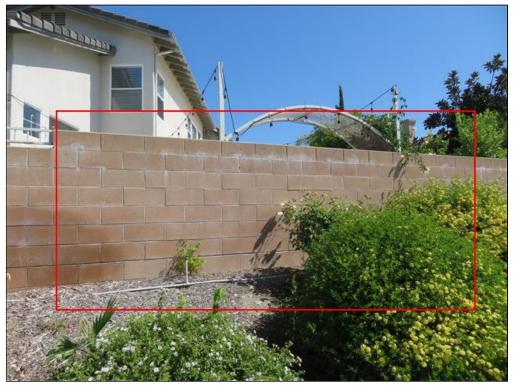
2.17 Item 1(Picture) Right side of the structure.

It appears that sprinkler water is spraying the perimeter fence; this can allow deterioration of the wall and stucco damage; we recommend switching to a drip system and repairs by a stucco professional.

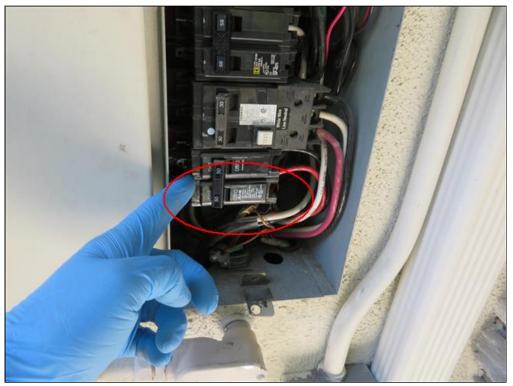
3.6 Item 1(Picture) Service panel.

Loose breakers we recommend evaluation by a licensed electrician for enhanced safety.

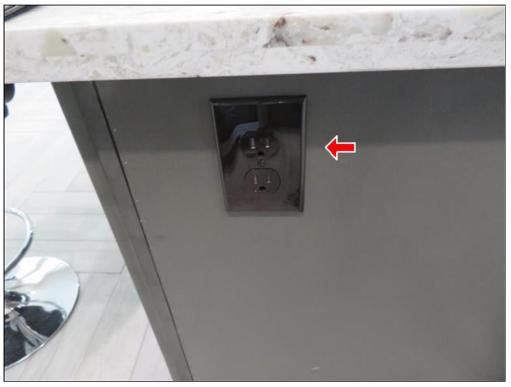
3.9 Item 2(Picture) Kitchen island.

We recommend that all outlets within 6' of wet areas be upgraded to GFCI for enhanced safety.

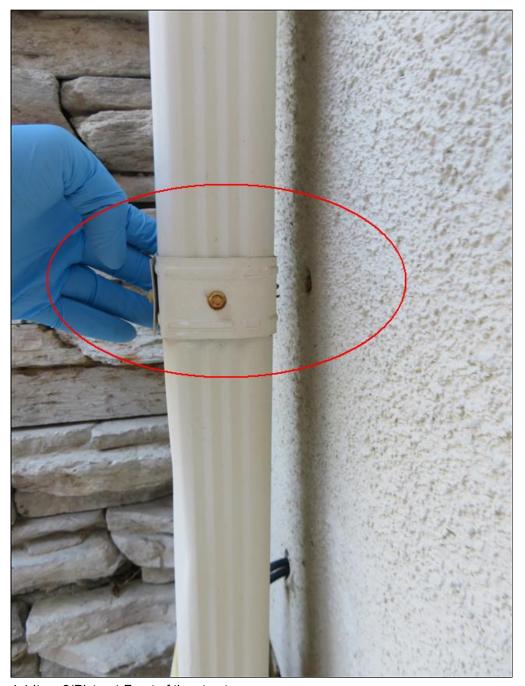
4.4 Item 2(Picture) Front of the structure.

The downspout at the front of the structure is not mounted to the wall; we recommend repairs.

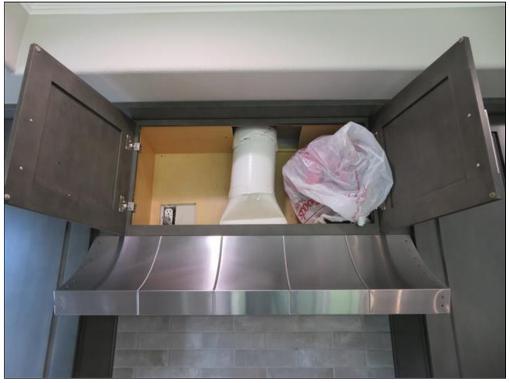
9.14 Item 1(Picture) Range exhaust.

(1) Disconnected at the exhaust, we recommend correction by securing with 3 metal sheet screws at each end and sealing with aluminum tape.

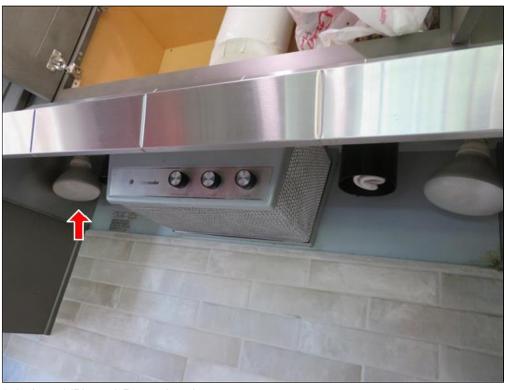
9.14 Item 3(Picture) Range hood.

(2) The left side heating bulb did not respond to test; we recommend replacement.

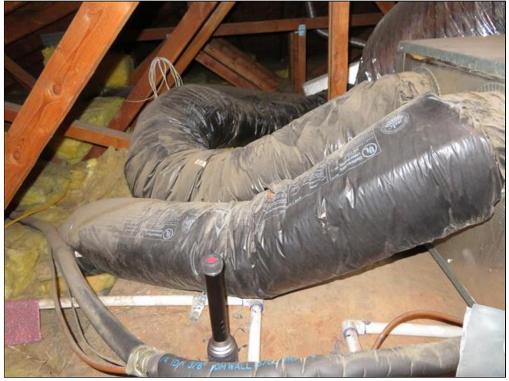
10.8 Item 1(Picture) HVAC ducting.

Aging ducts, we recommend leak testing, and budgeting for replacement. NOTE THAT DUCTS SHOULD NOT BE CLEANED.

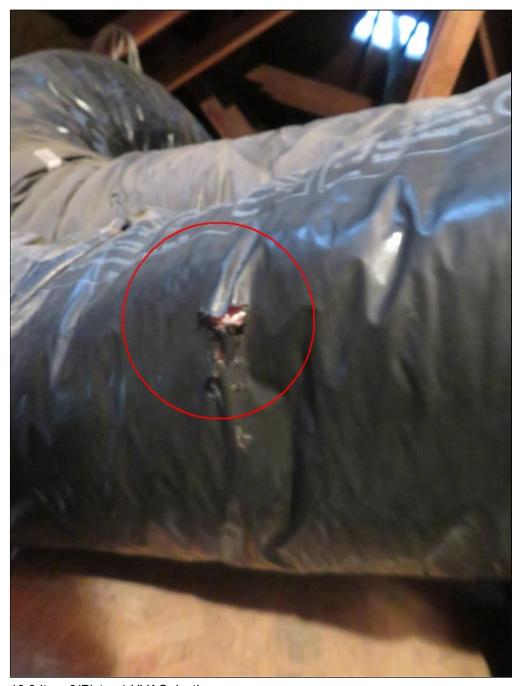
10.8 Item 3(Picture) HVAC ducting.

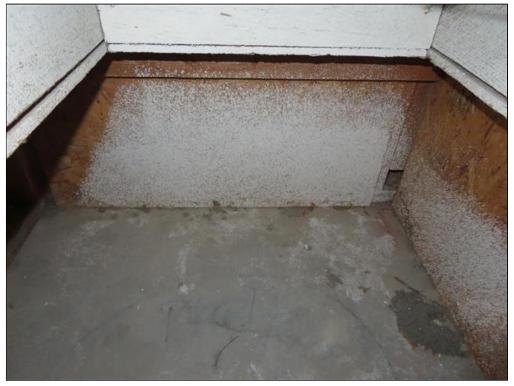
Lacks drywall enclosure, recommend installation to eliminate using air from inner walls of the structure.

10.9 Item 1(Picture) Air return chamber.

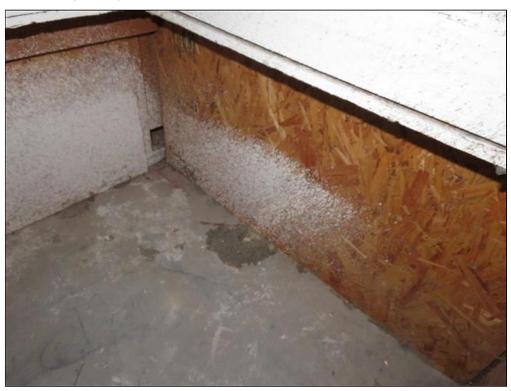
10.9 Item 2(Picture) Air return chamber.

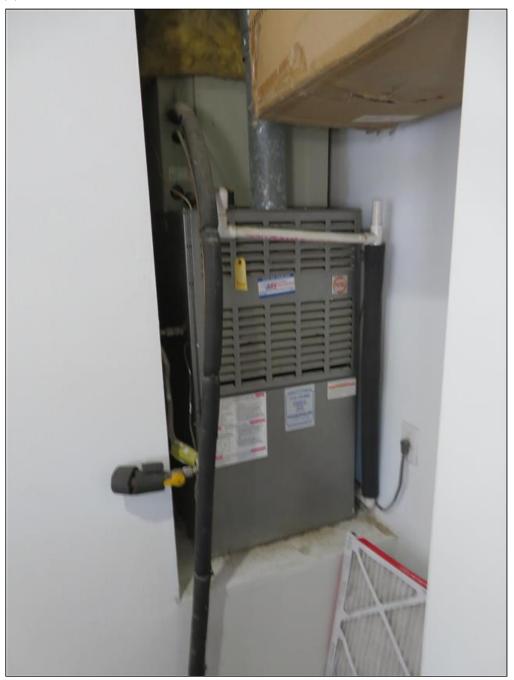
10.12 Item 1(Picture) HVAC.

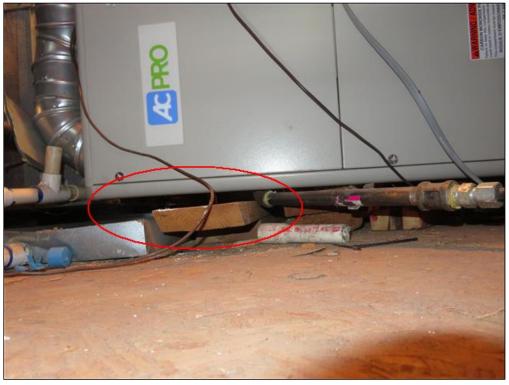
(2) The HVAC system located in the attic appeared to be mounted improperly; the system was resting on wood piers; we recommend correction by an HVAC contractor.

10.12 Item 3(Picture) HVAC.

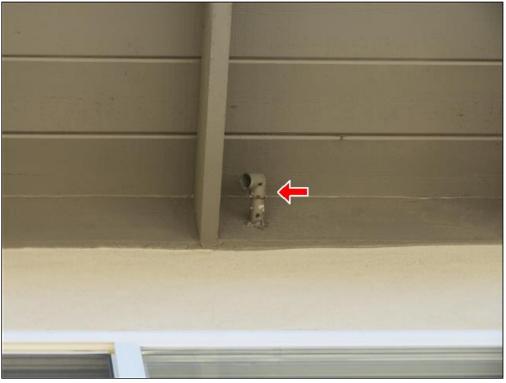
(2) The condensation drip line that terminates to the exterior appears to impact the side wall when draining; we recommend extending the drip line to ensure moisture does not come into contact with the cladding wall.

10.13 Item 1(Picture) Rear of the structure.

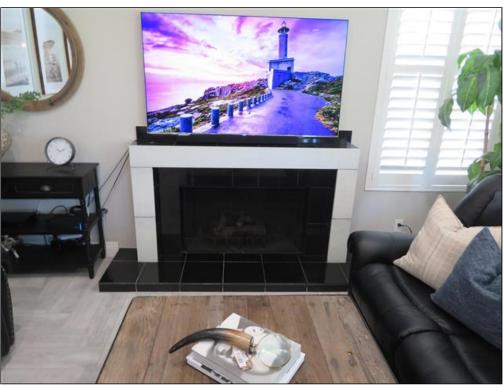
Gas appliance requires a clip at the damper to prevent full closure.

10.18 Item 1(Picture) Fireplace.

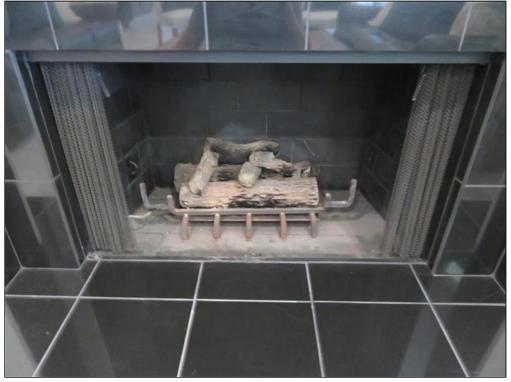
Missing screen, we recommend installation for enhanced safety.

Missing glass doors, we recommend installation for enhanced safety and energy conservation.

10.22 Item 1(Picture) Fireplace.

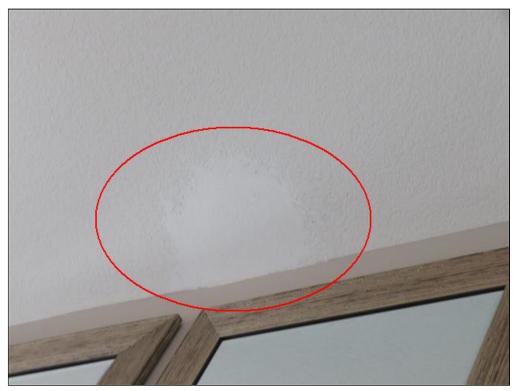
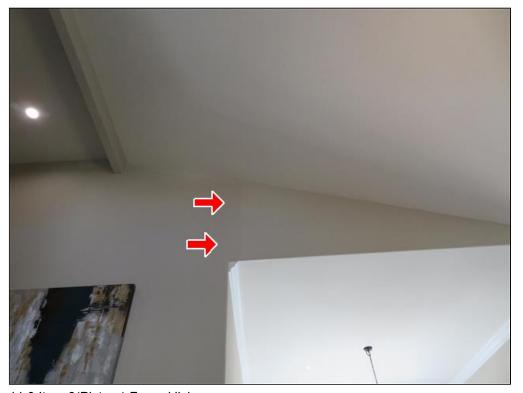
Signs of repairs noticed at the formal living room ceiling and kitchen ceiling; we recommend further inquiry of the seller.

11.0 Item 2(Picture) Formal living room.

11.0 Item 3(Picture) Formal living room.

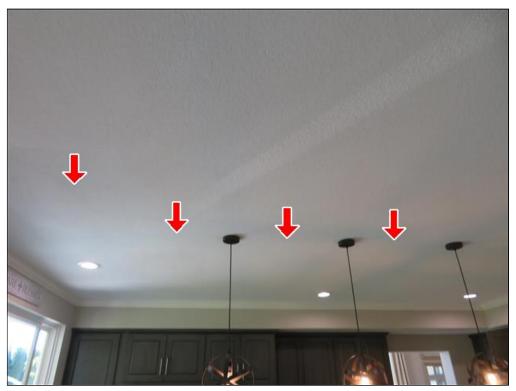
11.0 Item 4(Picture) Kitchen ceiling.

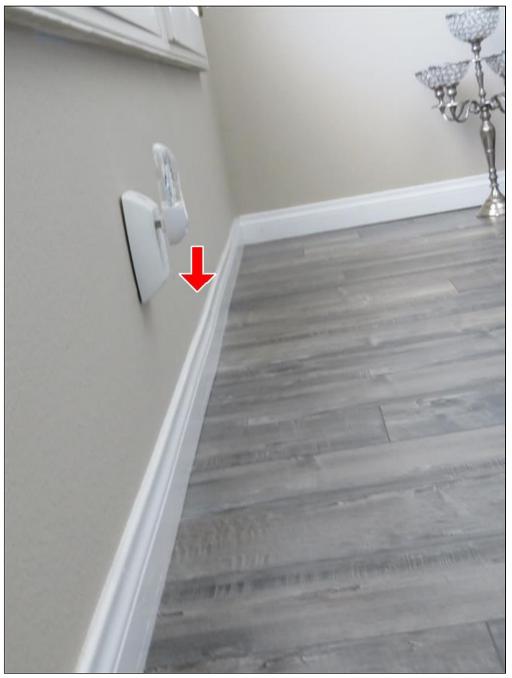
(1) Signs of warping at the master bedroom wall beneath the windows; this can be due to moisture intrusion from the exterior; we recommend further evaluation by a licensed contractor.

11.1 Item 2(Picture) Master bedroom.

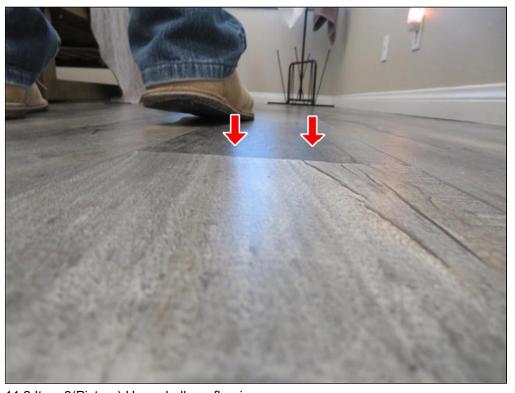
(2) Lifted flooring observed at the upper hallway; we recommend corrections by a licensed contractor.

11.2 Item 3(Picture) Upper hallway flooring.

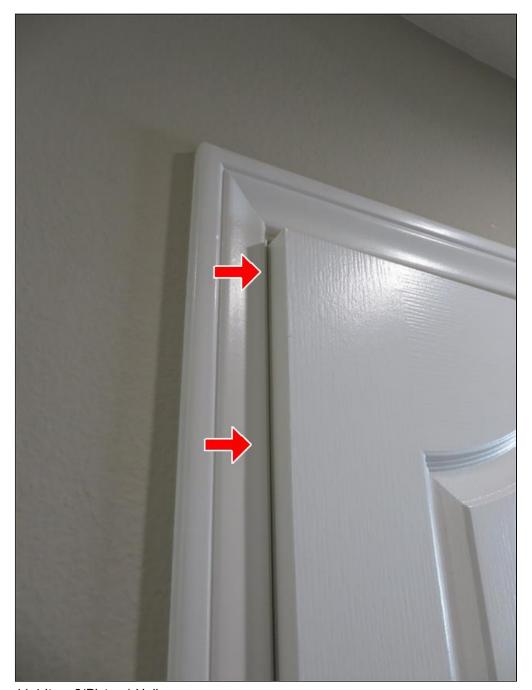
(1) Rubbed at frame at the hallway closet, we recommend correction by a qualified professional.

11.4 Item 2(Picture) Hallway.

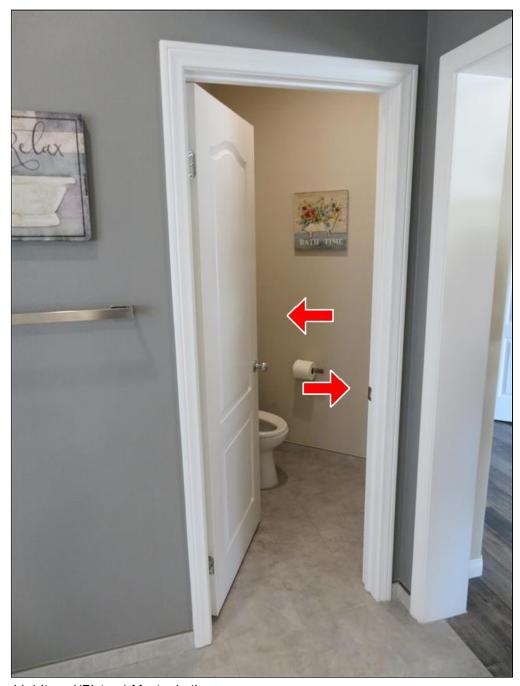
(2) Did not latch properly at the master bathroom toilet, we recommend correction.

11.4 Item 4(Picture) Master bathroom.

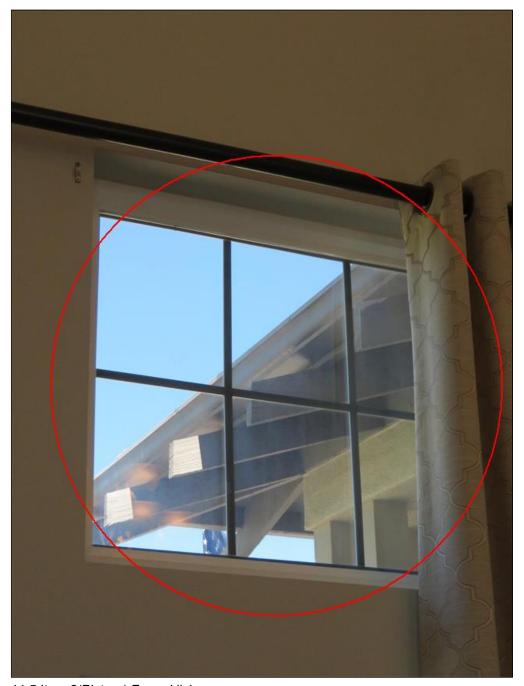
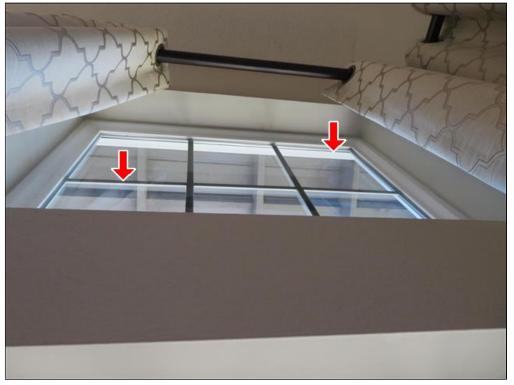
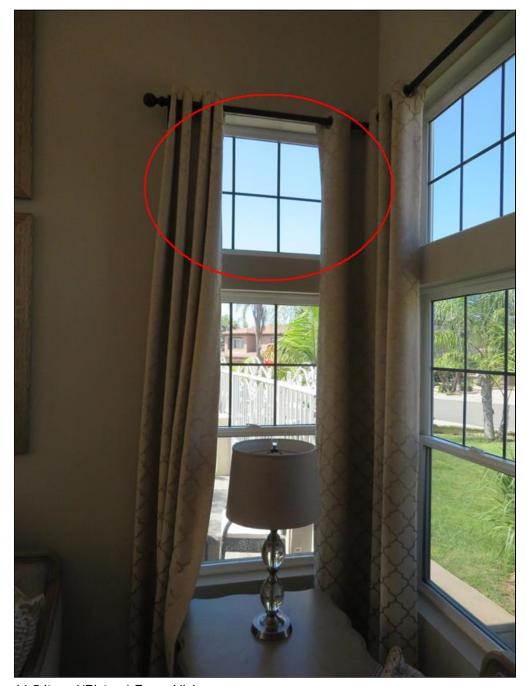
(1) Fogged windows indicate a failure of the energy efficiency of the window system; we recommend replacement. We identify all fogged windows that are readily visible during our inspection; however due to owner property and lighting conditions we may not be able to identify all defective conditions. Several window makers have extended warranties on failed window sills; we recommend further inquiry.

11.5 Item 2(Picture) Formal living room.

11.5 Item 3(Picture) Formal living room.

11.5 Item 4(Picture) Formal living room.

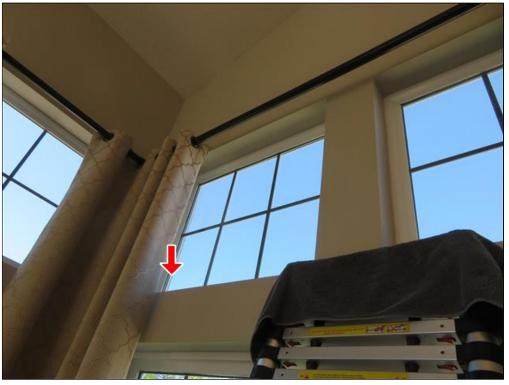
(2) Moisture staining observed at the formal living room window sill; this indicates a possible defective sill; we recommend further evaluation and corrections by a licensed window contractor.

11.5 Item 6(Picture) Formal living room.

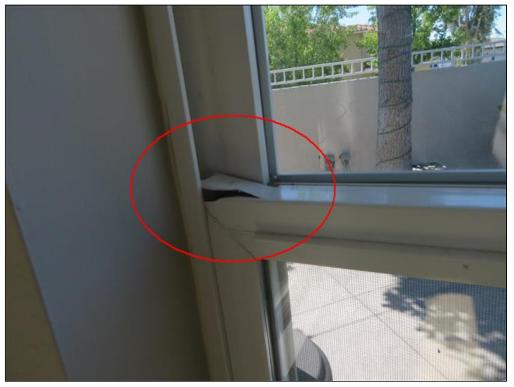
(3) Broken sash is a defect when a window will not remain in the open position, and can result in the window free falling to the sill; we recommend correction for safety.

11.5 Item 8(Picture) Formal living room.

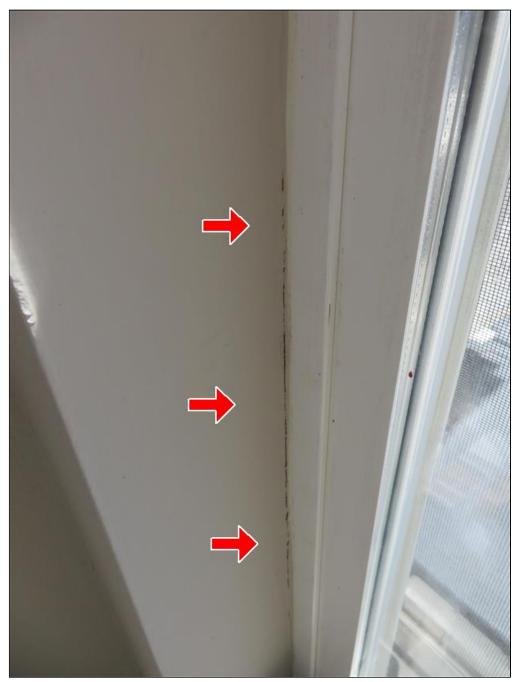
(4) Caulking deterioration observed at the dining room window; we recommend servicing.

11.5 Item 10(Picture) Dining room.

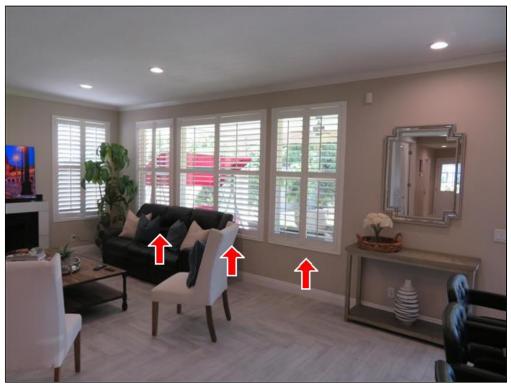
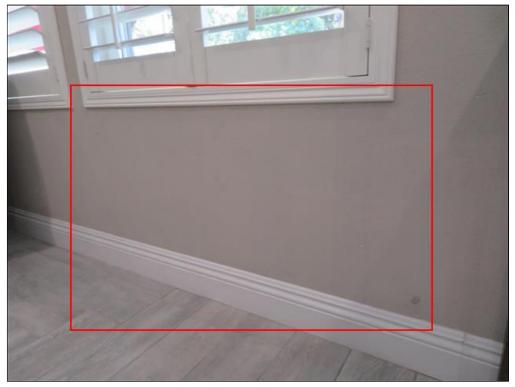
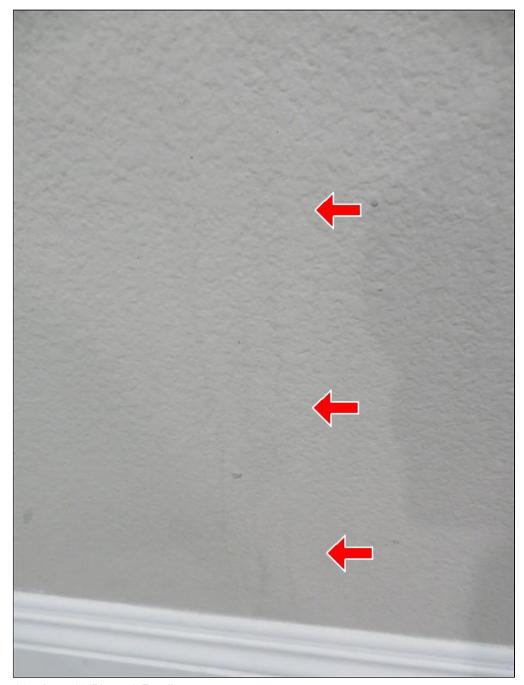
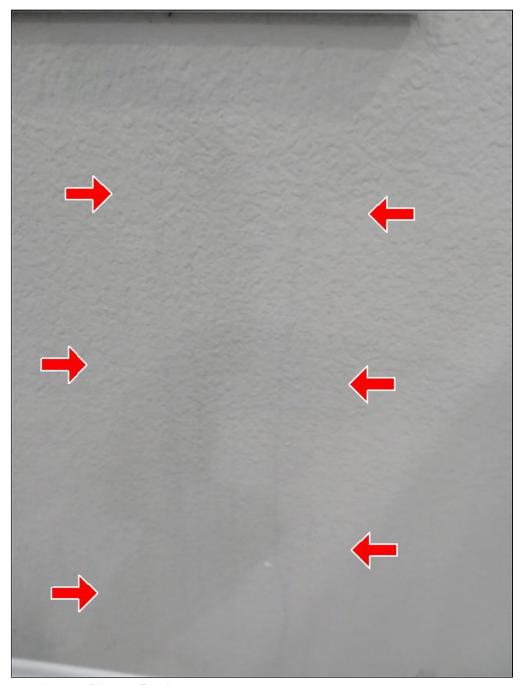
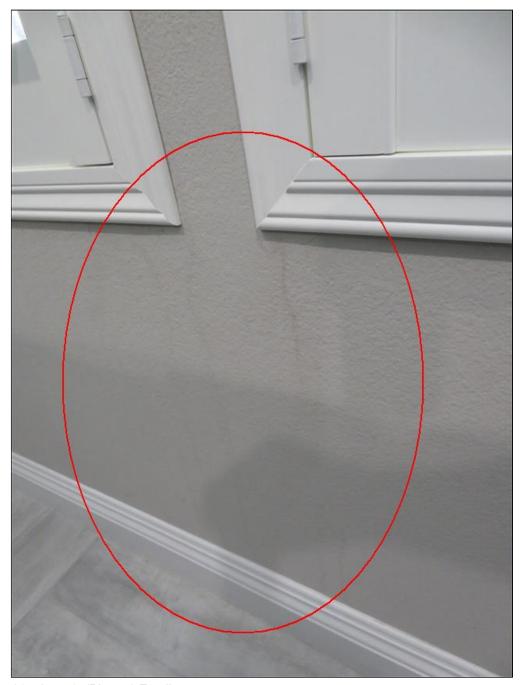
(5) Moisture intrusion at sills at the family room and master bedroom, this is an indication of leakage, we recommend leak testing of the windows and repairs as needed by a licensed window contractor.

11.5 Item 11(Picture) Family room.

11.5 Item 12(Picture) Family room.

11.5 Item 13(Picture) Family room.

11.5 Item 14(Picture) Family room.

11.5 Item 15(Picture) Family room.

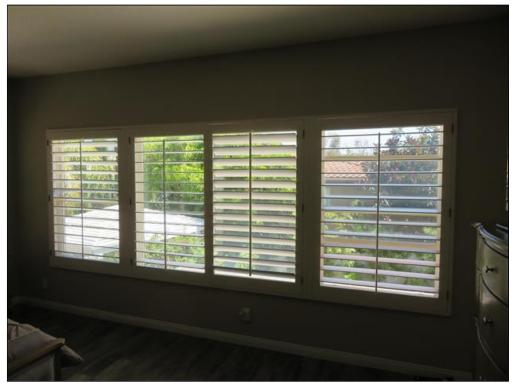
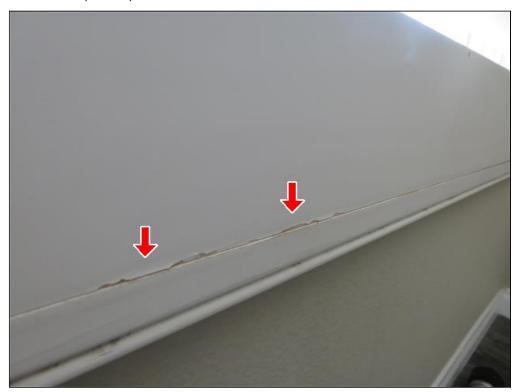
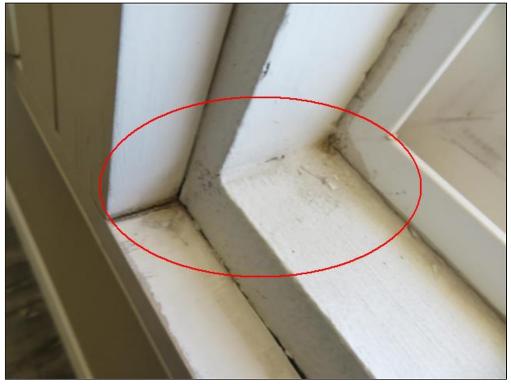
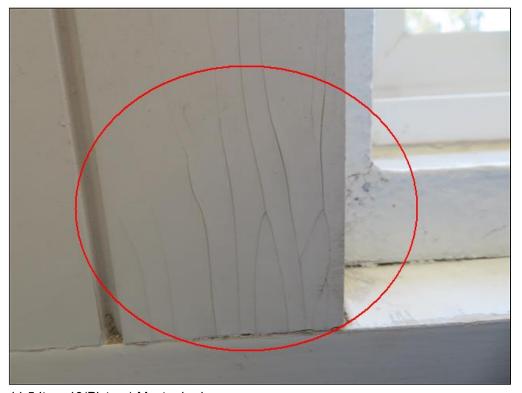
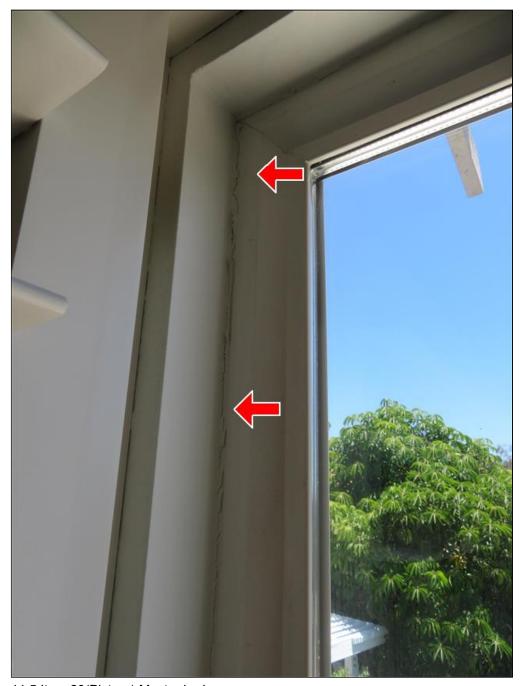
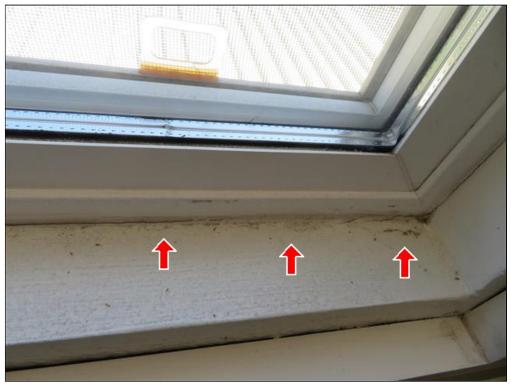
11.5 Item 16(Picture) Master bedroom.

11.5 Item 17(Picture) Master bedroom.

11.5 Item 18(Picture) Master bedroom.

11.5 Item 19(Picture) Master bedroom.

11.5 Item 20(Picture) Master bedroom.

11.5 Item 21(Picture) Master bedroom.

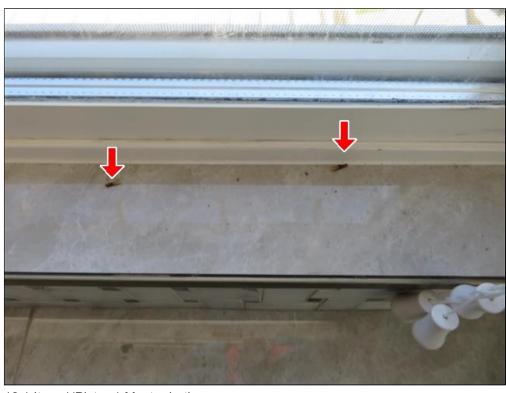
Possible termites observed at the master bathroom window sill; we recommend further evaluation by a termite professional.

12.1 Item 1(Picture) Master bathroom.

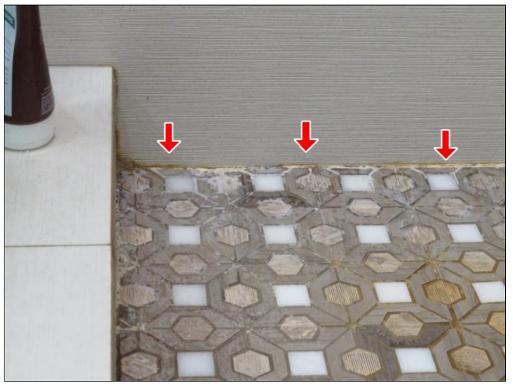
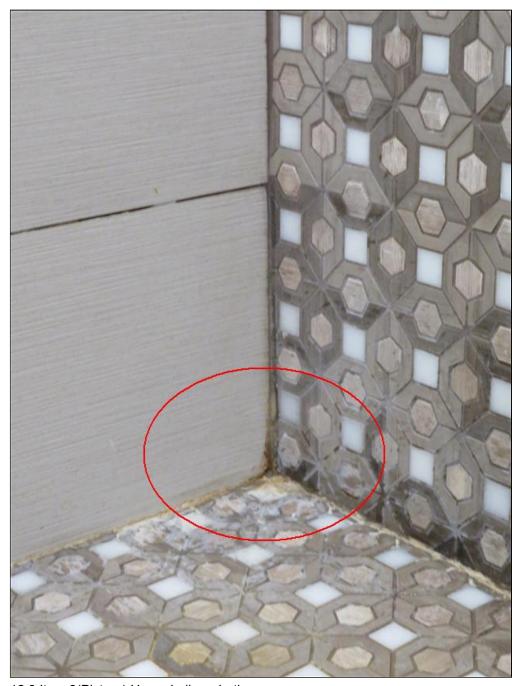
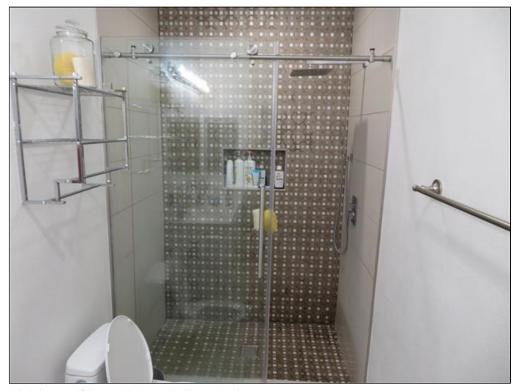
Caulking deterioration observed at the upper hallway bathroom shower enclosure; this condition can result in water seeping between the shower surface and liner and can result in mold growth; we recommend re-caulking.

12.8 Item 2(Picture) Upper hallway bathroom.

12.8 Item 3(Picture) Upper hallway bathroom.

12.8 Item 4(Picture) Upper hallway bathroom.

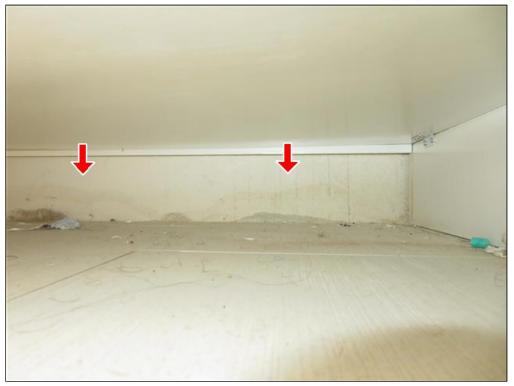
There were moisture stains observed at the upper hallway bathroom wall behind the vanity; this can be due to a historic moisture event; we recommend further evaluation by a plumber to verify that the moisture source has been corrected.

12.11 Item 1(Picture) Upper hallway bathroom.

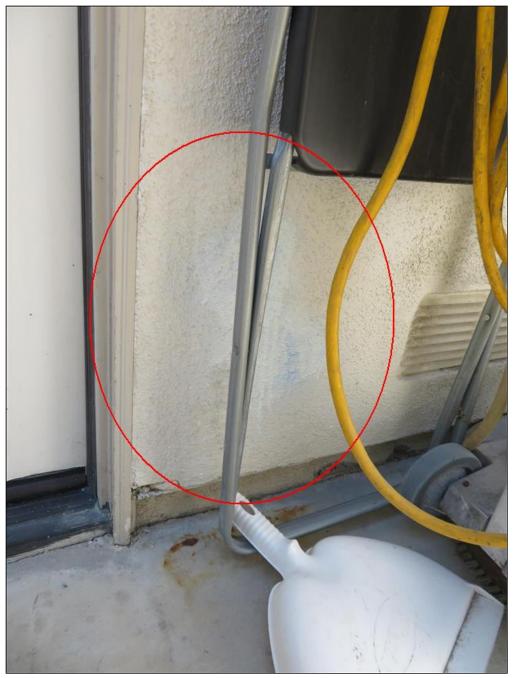
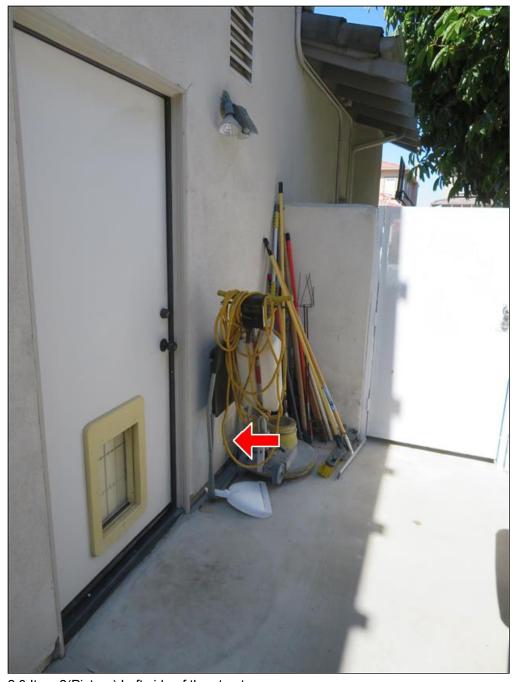
(1) Signs of stucco repairs observed at the left side of the structure; we recommend further inquiry of the seller.

2.0 Item 1(Picture) Left side of the structure.

2.0 Item 2(Picture) Left side of the structure.

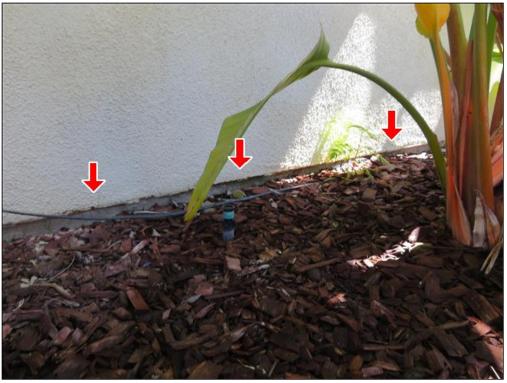
(2) Poor weep screed clearance (2" above paving; 4" above soil); this condition results in corrosion, and unwanted moisture intrusion into the wall and interior that may not be readily visible.

2.0 Item 3(Picture) Left side of the structure (planter)

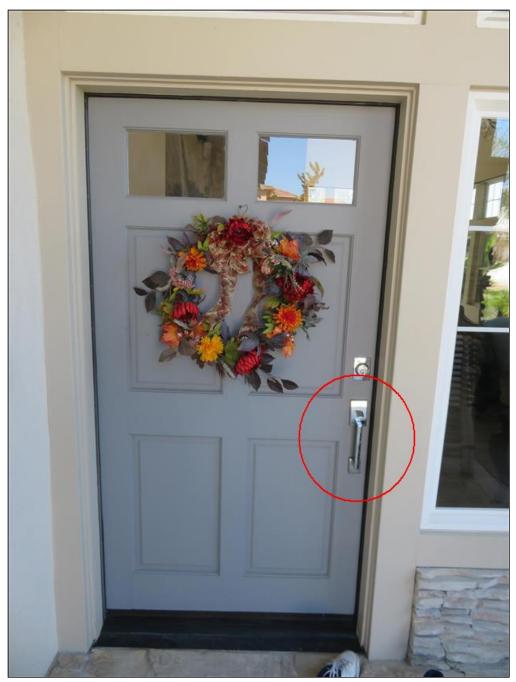
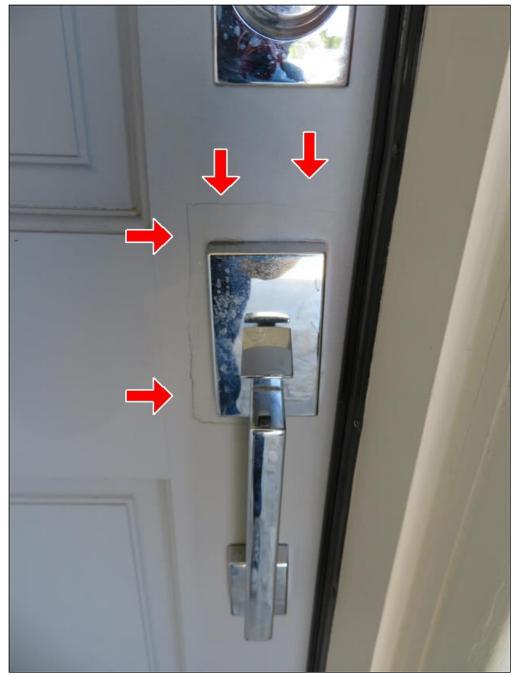
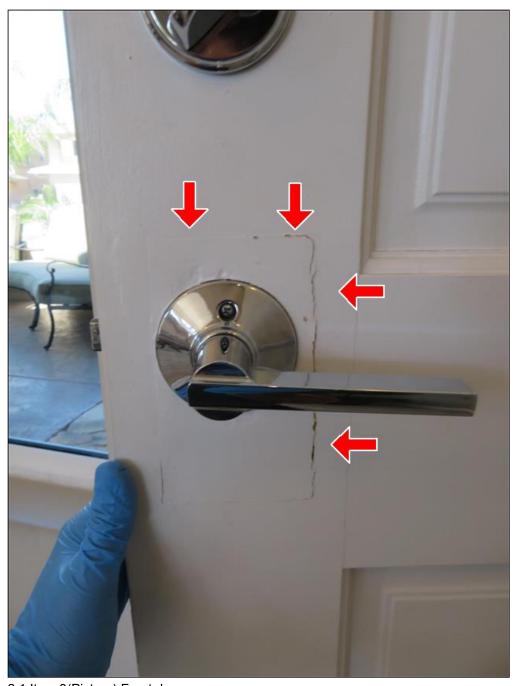
The front door handle appears to have been replaced; cracks exist around the handle; we recommend repairs.

2.1 Item 1(Picture) Front door.

2.1 Item 2(Picture) Front door.

2.1 Item 3(Picture) Front door.

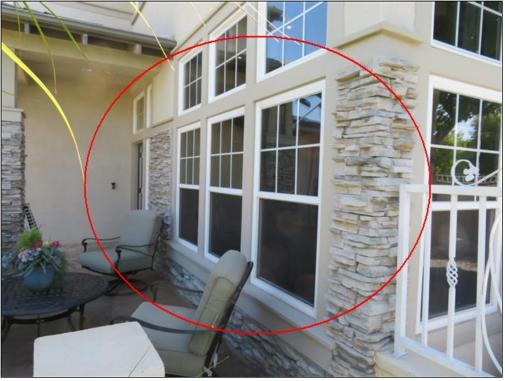
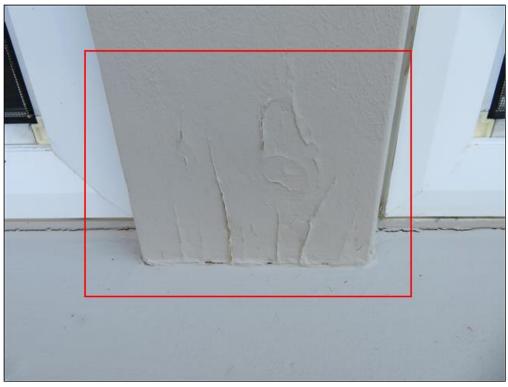
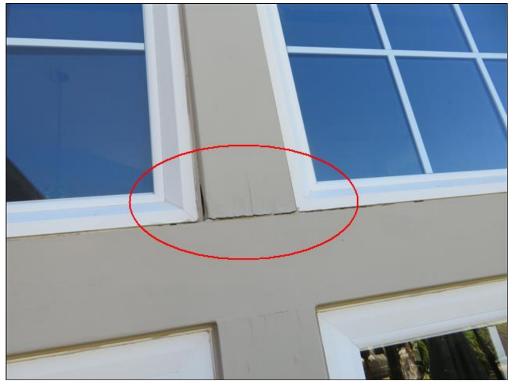
(1) The wood trim at the exterior window front of the structure are moisture damaged; we recommend further evaluation and repairs by a termite professional.

2.2 Item 1(Picture) Front of the structure.

2.2 Item 2(Picture) Front of the structure.

2.2 Item 3(Picture) Front of the structure.

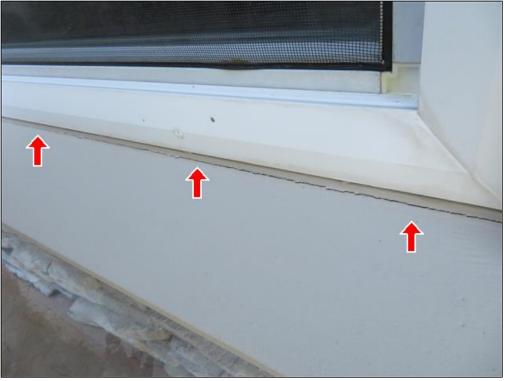
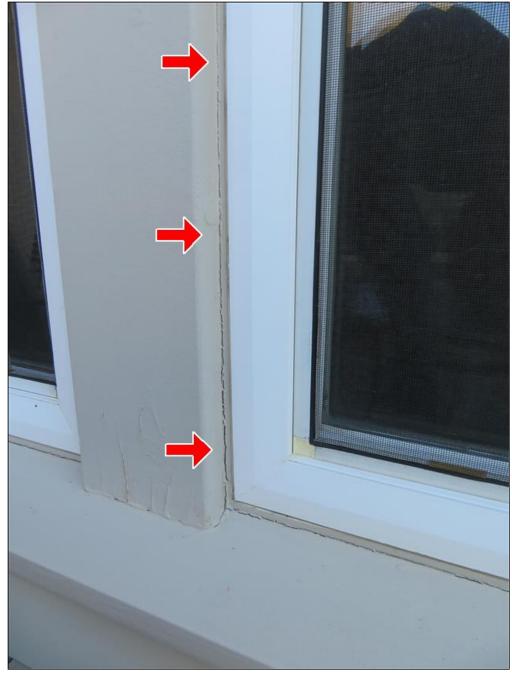
(2) Caulking deterioration at the front of the structure, we recommend servicing.

2.2 Item 4(Picture) Front of the structure.

2.2 Item 5(Picture) Front of the structure.

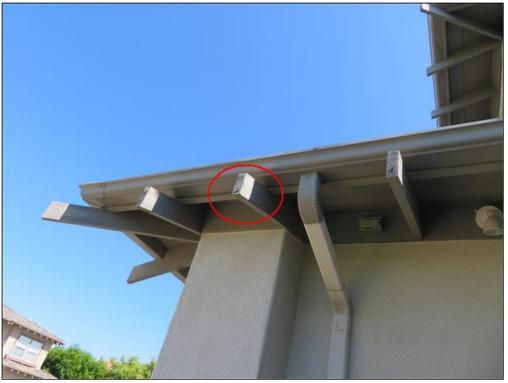
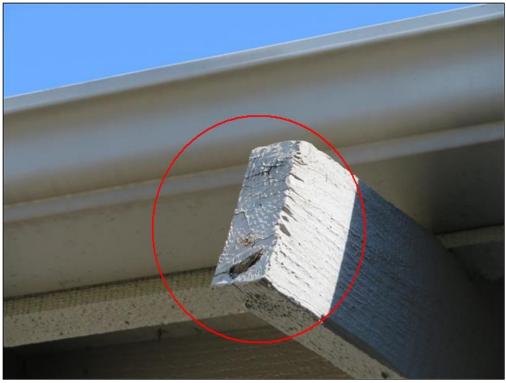
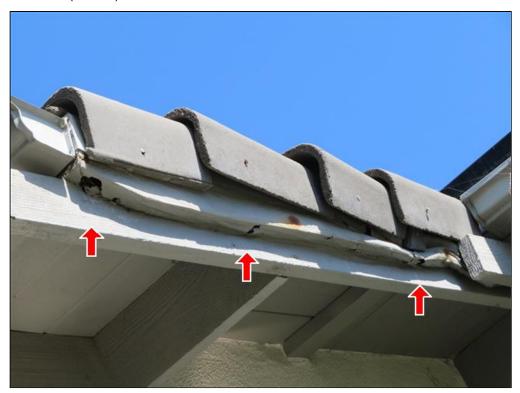
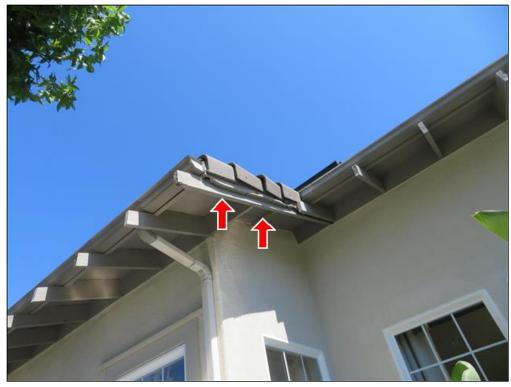
Moisture damage; we recommend further evaluation by a termite professional, to determine the extent of moisture damage to the wood structure.

2.4 Item 1(Picture) Front of the structure.

2.4 Item 2(Picture) Front of the structure.

2.4 Item 3(Picture) Right side of the structure.

2.4 Item 4(Picture) Right side of the structure.

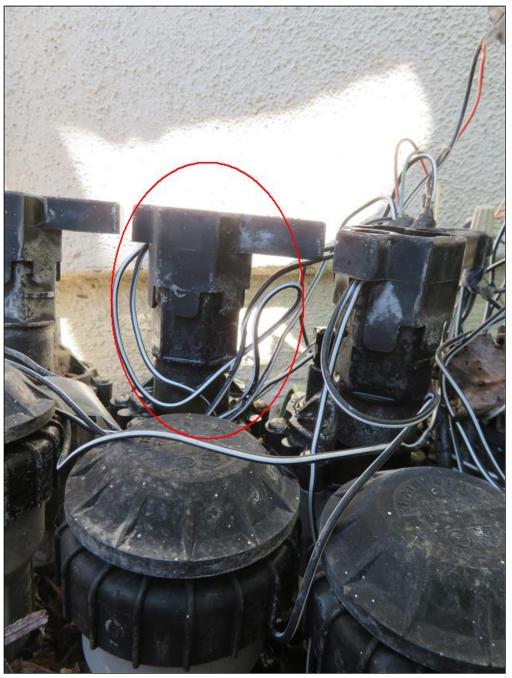
2.12 Item 1(Picture) Right side of the structure.

Sprinkler system leaking at the right side of the structure; we recommend corrections by a plumber.

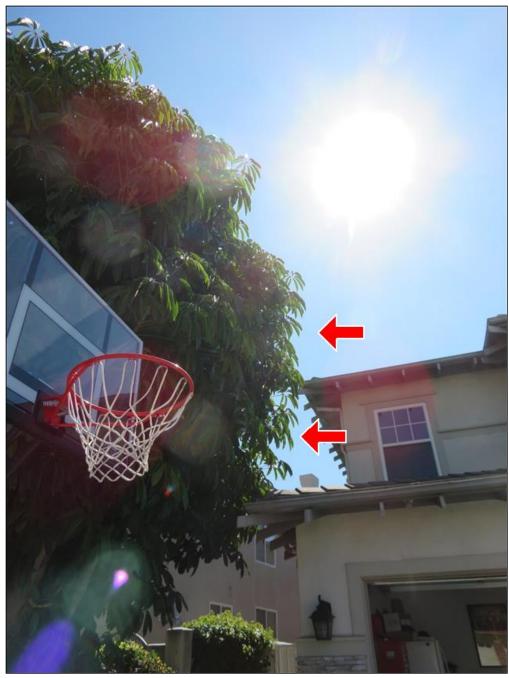
2.15 Item 1(Picture) Roof.

(1) Neighbor tree over roof area, we recommend trimming to protect the roof coverings.

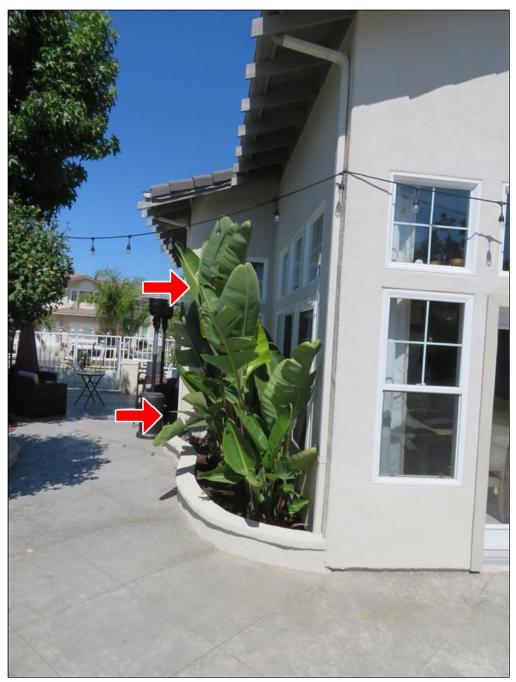
2.15 Item 2(Picture) Right side of the structure.

(2) Touching the structure, we recommend trimming.

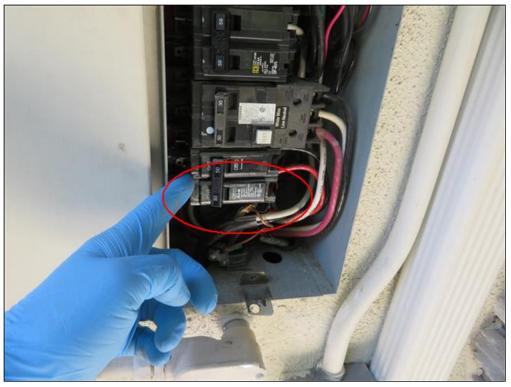
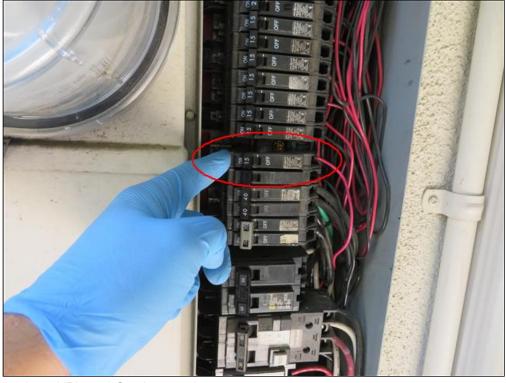
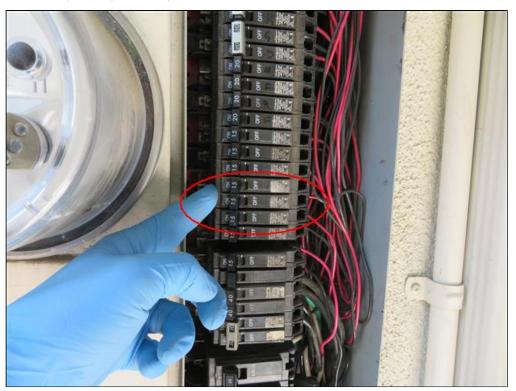
Loose breakers we recommend evaluation by a licensed electrician for enhanced safety.

3.6 Item 1(Picture) Service panel.

3.6 Item 2(Picture) Service panel.

3.6 Item 3(Picture) Service panel.
