Inspection Report

Sample Report

Property Address: 456 Main St. Irvine CA

Date: 11/21/2019	Time: 10:00 AM	Report ID: MainStlrvine
Property: 456 Main St. Irvine CA	Customer: Sample Report	Real Estate Professional:

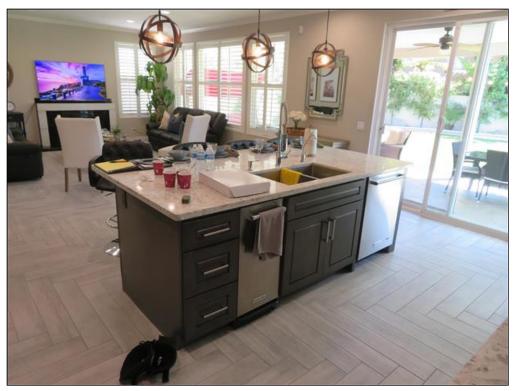
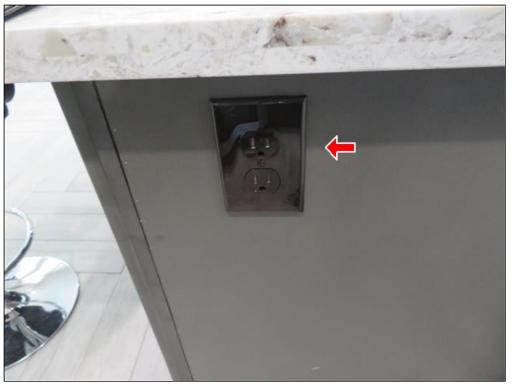
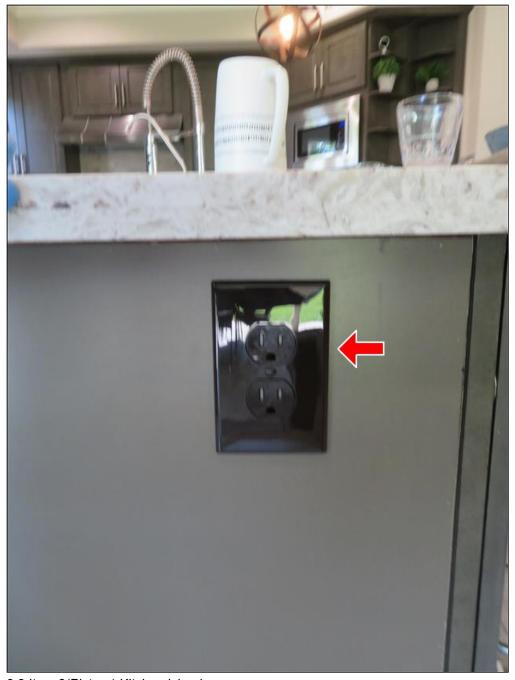
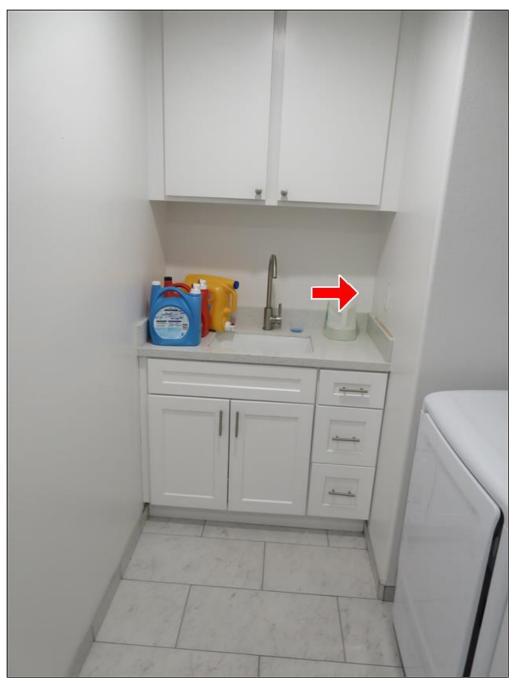
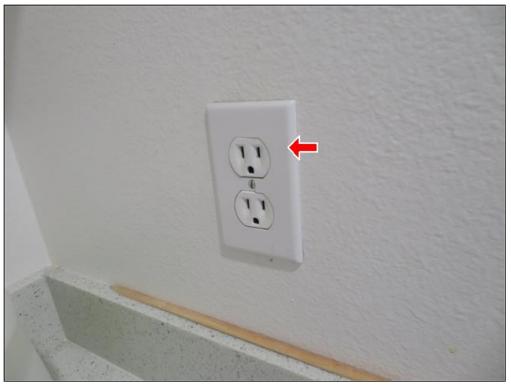
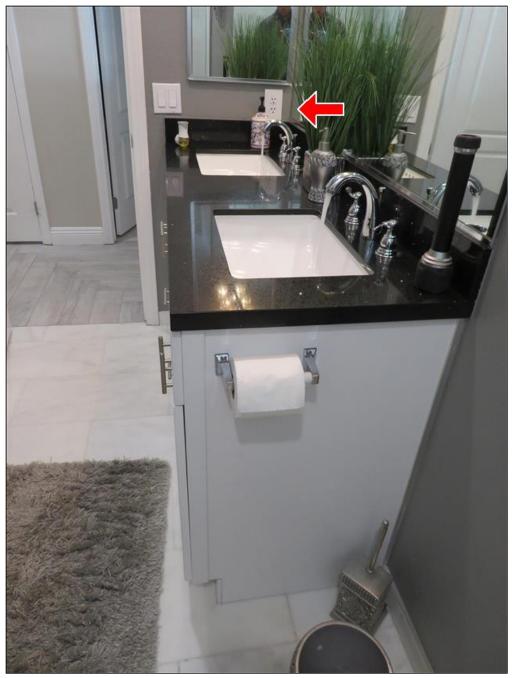
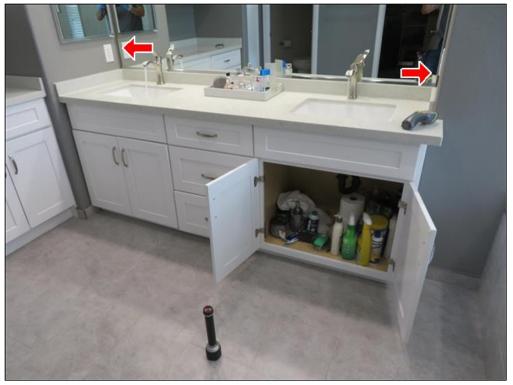
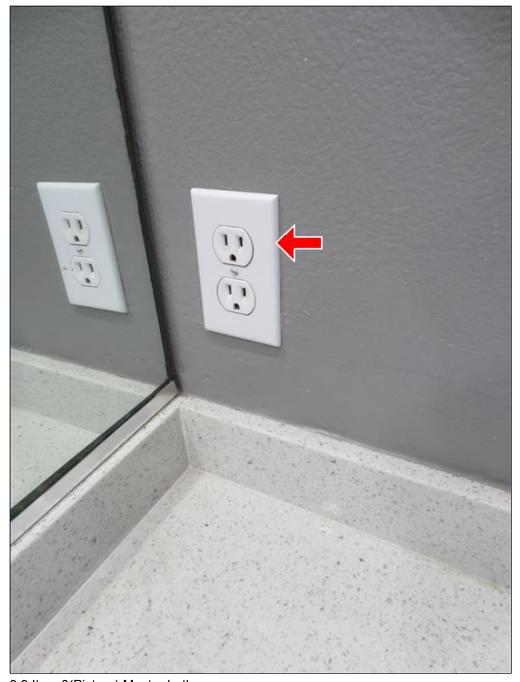
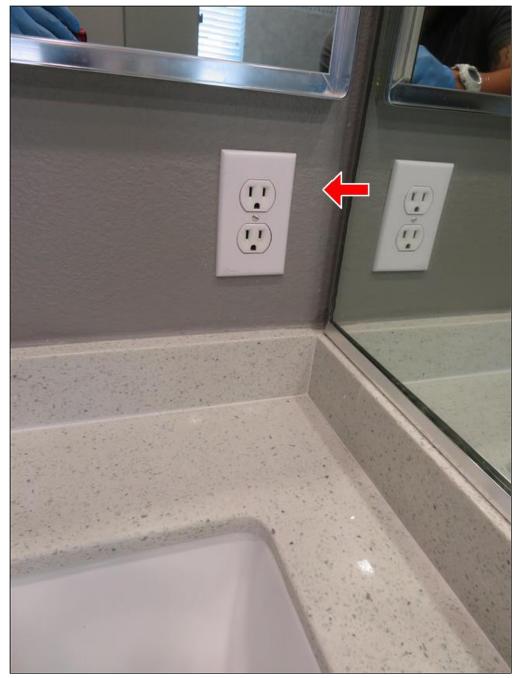
We recommend that all outlets within 6' of wet areas be upgraded to GFCI for enhanced safety.

3.9 Item 1(Picture) Kitchen island.

3.9 Item 2(Picture) Kitchen island.

3.9 Item 3(Picture) Kitchen island.

3.9 Item 4(Picture) Laundry room.

3.9 Item 5(Picture) Laundry room.

3.9 Item 6(Picture) Lower hallway bathroom.

3.9 Item 7(Picture) Master bathroom.

3.9 Item 8(Picture) Master bathroom.

3.9 Item 9(Picture) Master bathroom.

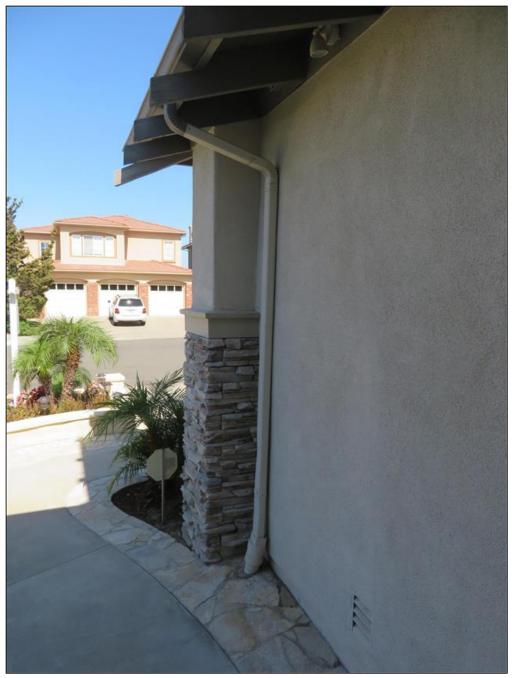
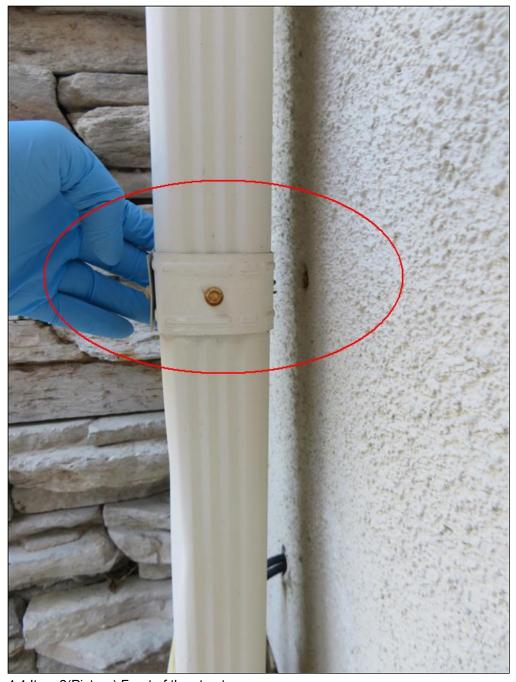
The downspout at the front of the structure is not mounted to the wall; we recommend repairs.

4.4 Item 1(Picture) Front of the structure.

4.4 Item 2(Picture) Front of the structure.

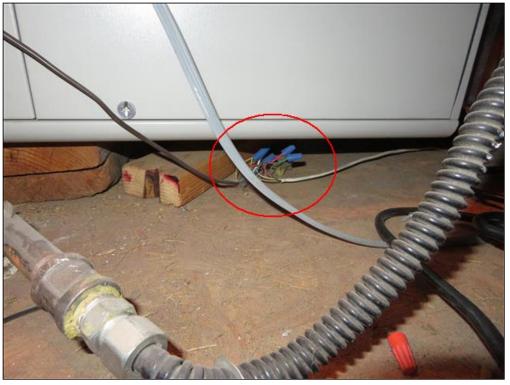
4.10 Item 1(Picture) Attic.

Exposed splices, we recommend a complete evaluation of the electrical system in the attic since this is an indication that work was not completed by a licensed electrician; this is a safety hazard.

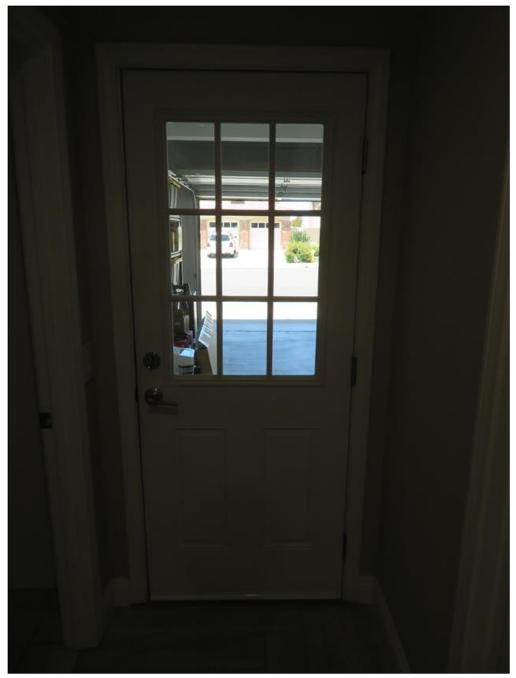
6.6 Item 1(Picture) Garage door.

The occupant door from inside garage to inside the home is not a fire rated door. This means that should a fire occur in garage, the occupant door does not afford protection until fireman arrive. This door should be replaced with a fire rated door.

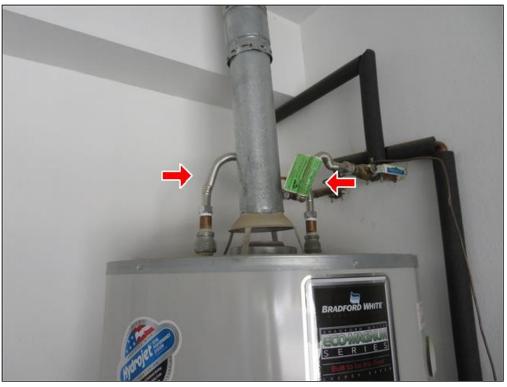
8.2 Item 1(Picture) Water heater.

Hot and cold water lines are missing R-4 insulation, we recommend installation for energy savings.

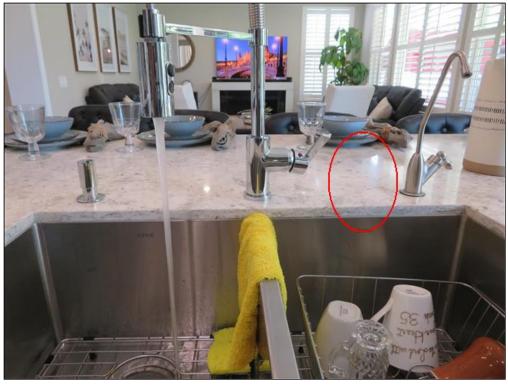
9.12 Item 1(Picture) Air gap.

Not installed, this can result in waste water mixing into the clean cycle; note that a few models have an internal air gap (which is not common); recommend installation for water quality safety.

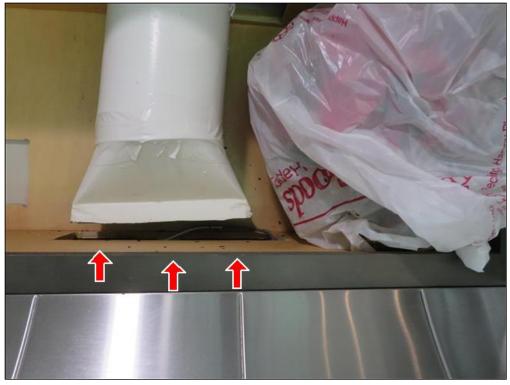
9.14 Item 2(Picture) Range exhaust.

(1) Disconnected at the exhaust, we recommend correction by securing with 3 metal sheet screws at each end and sealing with aluminum tape.

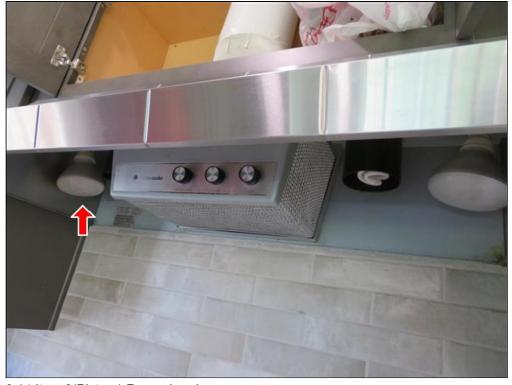
9.14 Item 3(Picture) Range hood.

(2) The left side heating bulb did not respond to test; we recommend replacement.

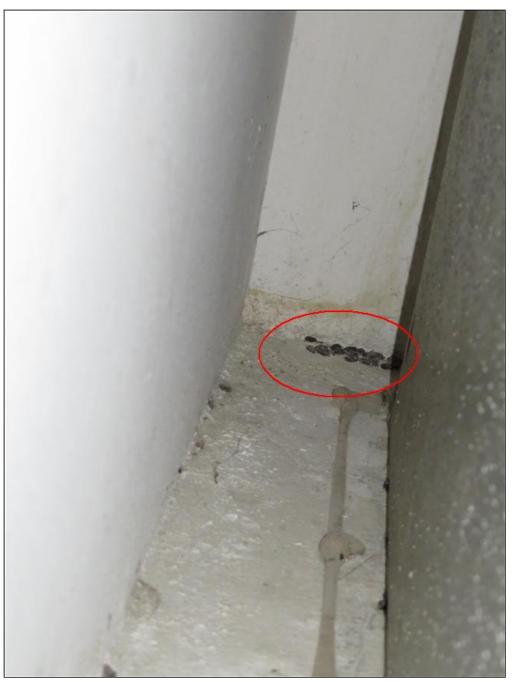
10.6 Item 2(Picture) HVAC enclosure.

Possible rodent droppings observed at the HVAC enclosure; we recommend further evaluation and cleanup by a integrated pest control specialist.

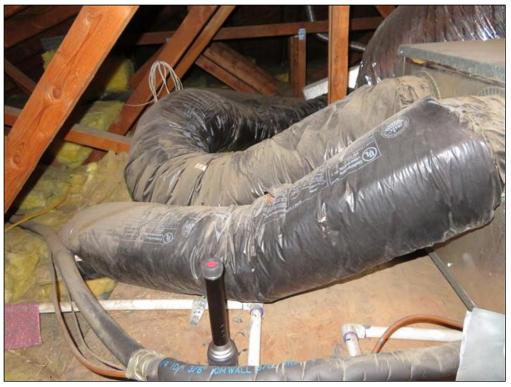
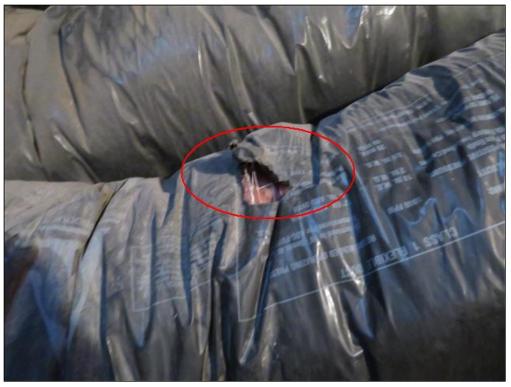
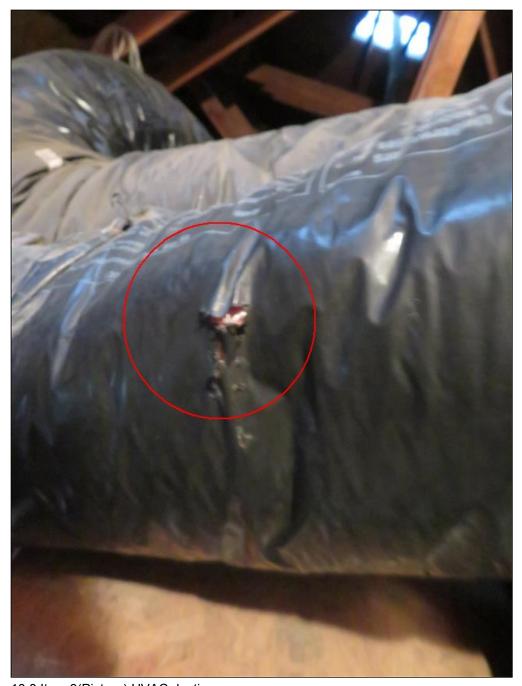
Aging ducts, we recommend leak testing, and budgeting for replacement. NOTE THAT DUCTS SHOULD NOT BE CLEANED.

10.8 Item 1(Picture) HVAC ducting.

10.8 Item 2(Picture) HVAC ducting.

10.8 Item 3(Picture) HVAC ducting.

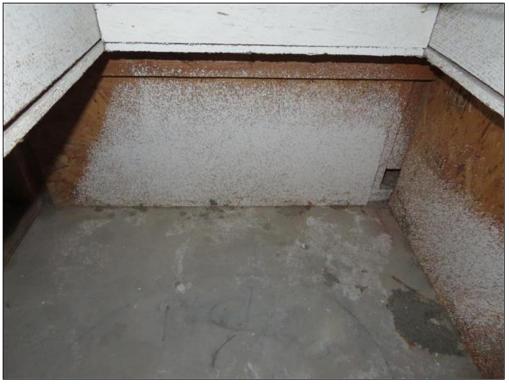
10.9 Item 1(Picture) Air return chamber.

Lacks drywall enclosure, recommend installation to eliminate using air from inner walls of the structure.

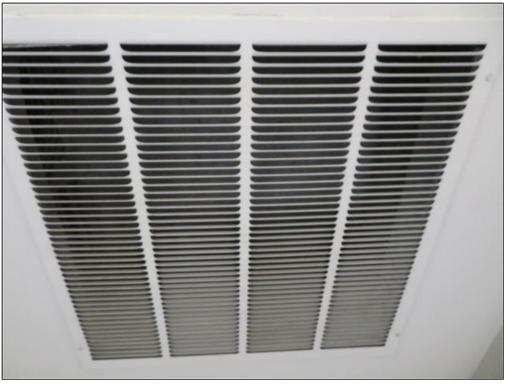
10.10 Item 1(Picture) Lower hallway.

(1) Missing at the air return; we recommend replacement with an allergy rated disposable filter.

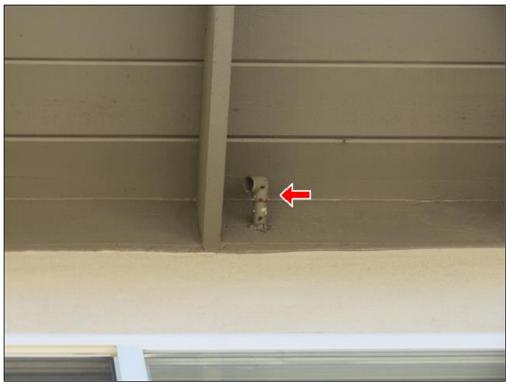
10.13 Item 1(Picture) Rear of the structure.

- (1) Not fully visible, leak testing is beyond the scope.
- (2) The condensation drip line that terminates to the exterior appears to impact the side wall when draining; we recommend extending the drip line to ensure moisture does not come into contact with the cladding wall.

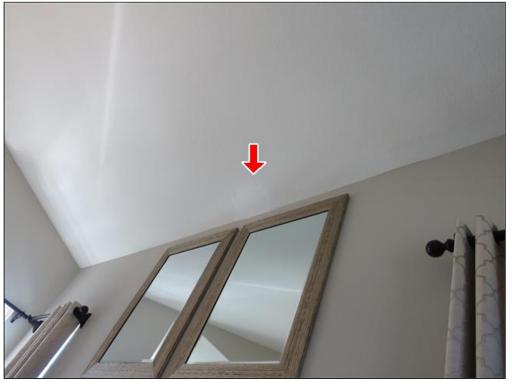
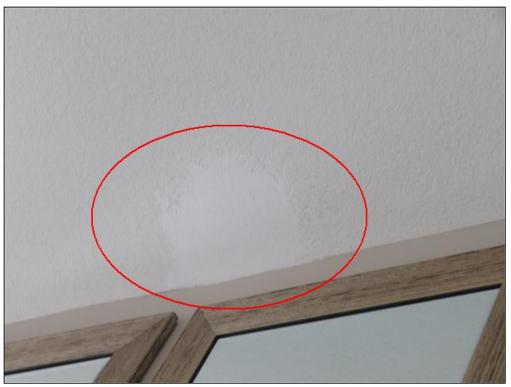
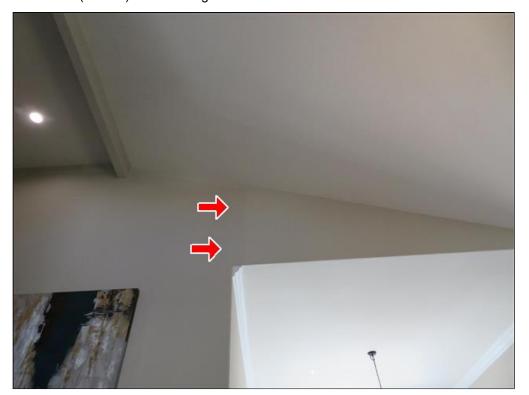
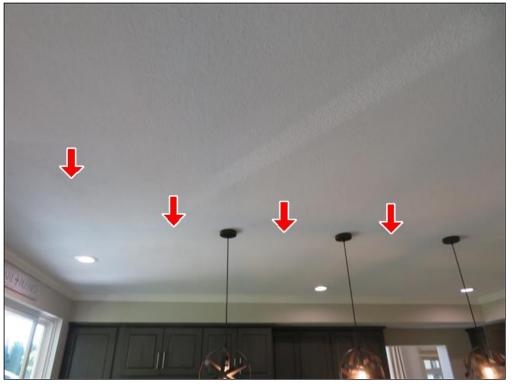
Signs of repairs noticed at the formal living room ceiling and kitchen ceiling; we recommend further inquiry of the seller.

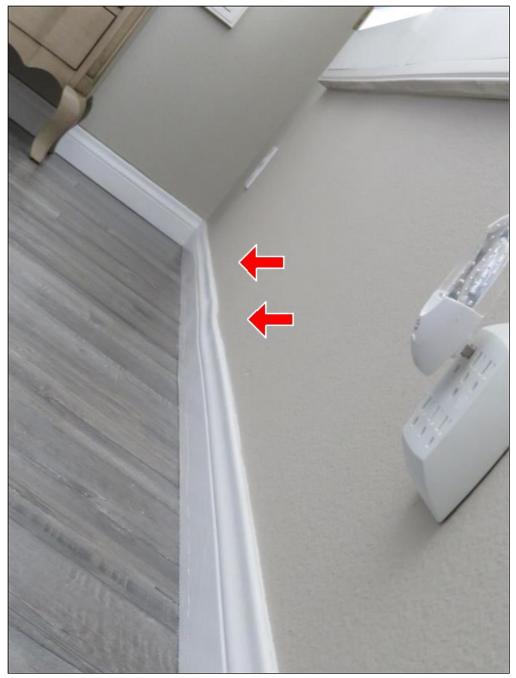
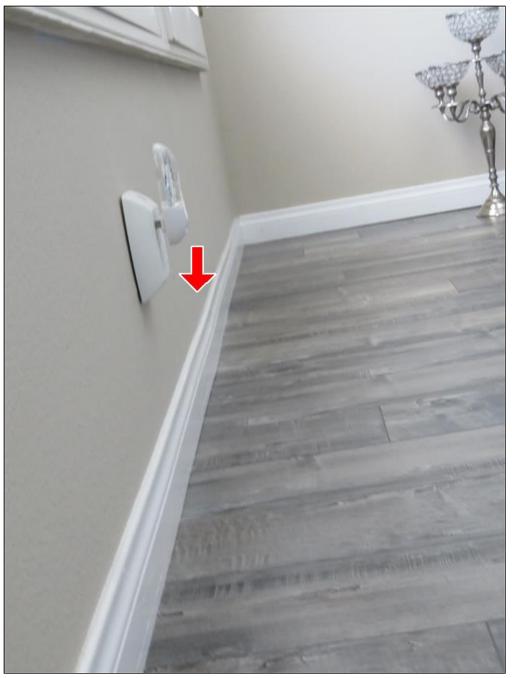
(1) Signs of warping at the master bedroom wall beneath the windows; this can be due to moisture intrusion from the exterior; we recommend further evaluation by a licensed contractor.

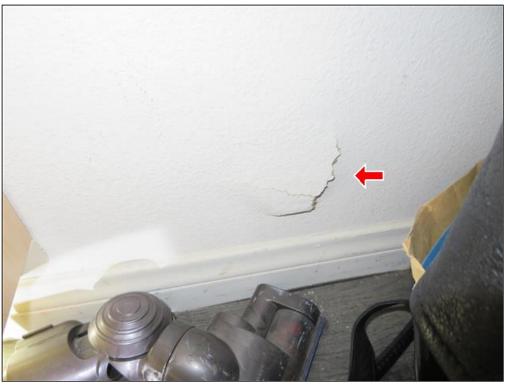
11.1 Item 3(Picture) Master bedroom.

(2) There was damaged observed at the master bedroom closet lower wall; we recommend repairs.

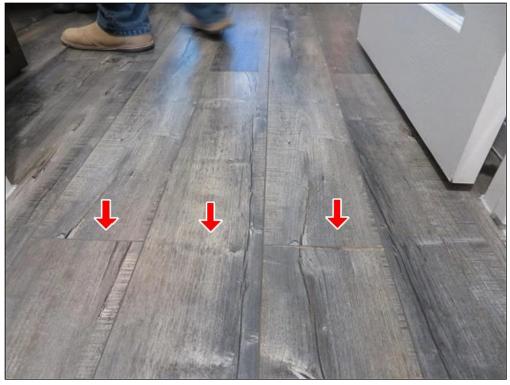
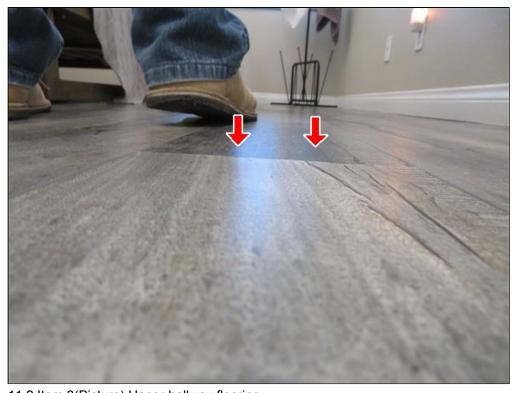
(2) Lifted flooring observed at the upper hallway; we recommend corrections by a licensed contractor.

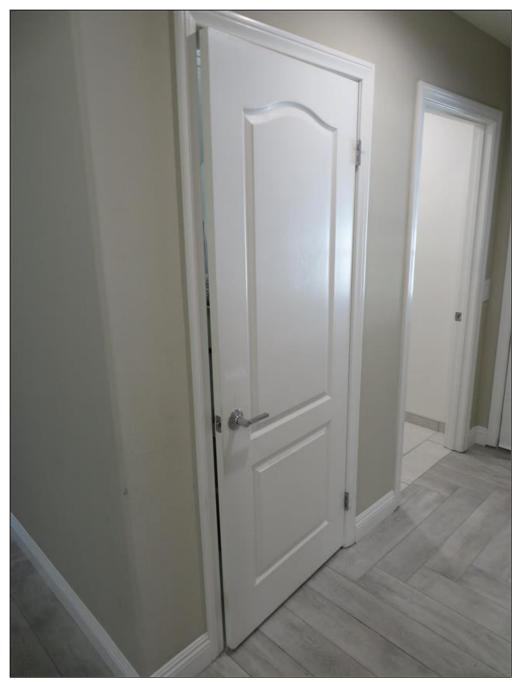
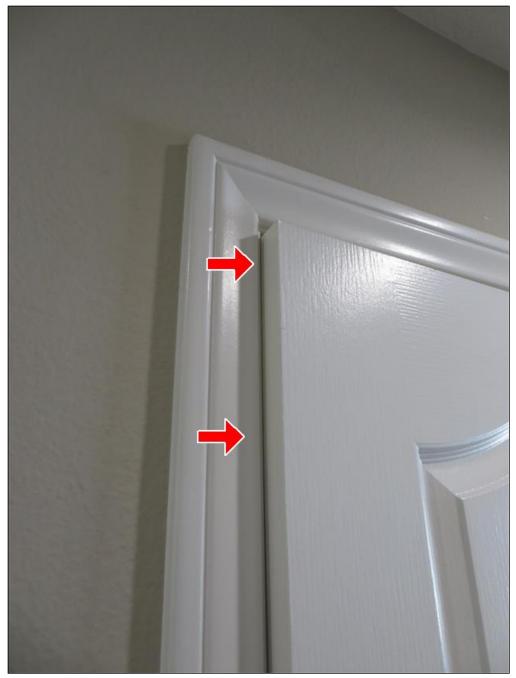
(1) Rubbed at frame at the hallway closet, we recommend correction by a qualified professional.

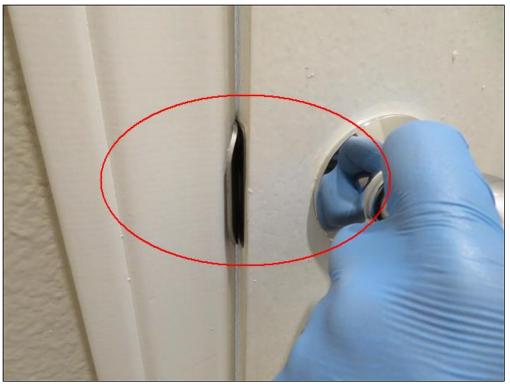
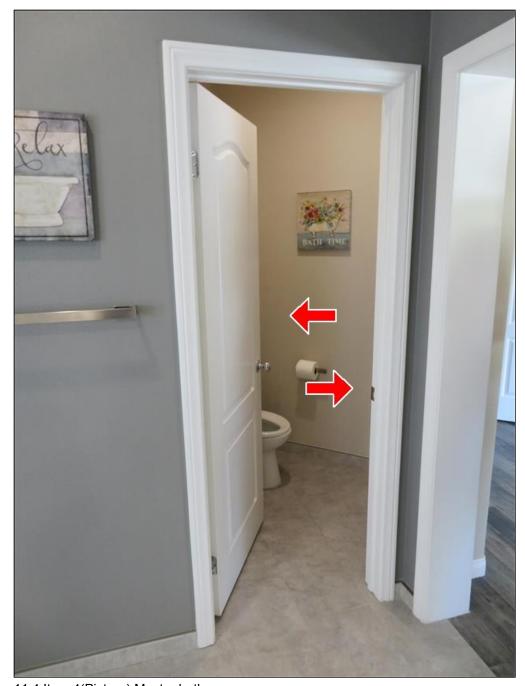
(2) Did not latch properly at the master bathroom toilet, we recommend correction.

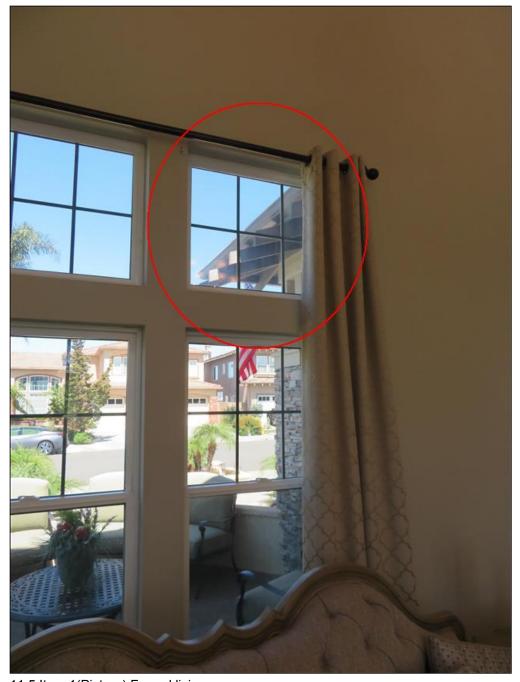
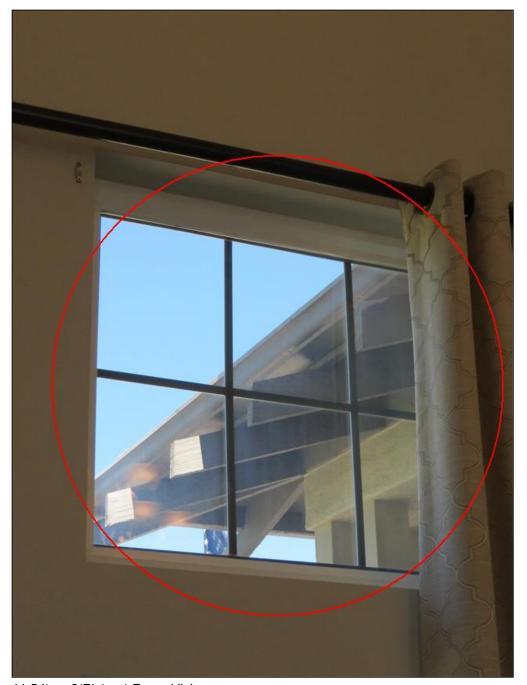
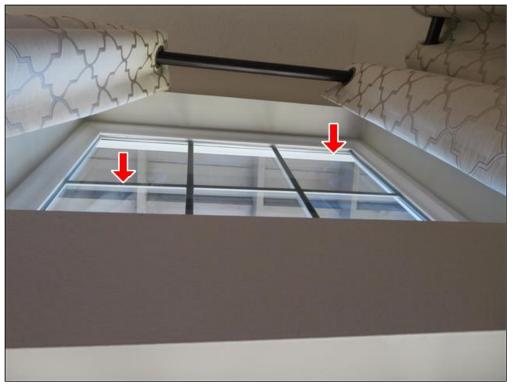
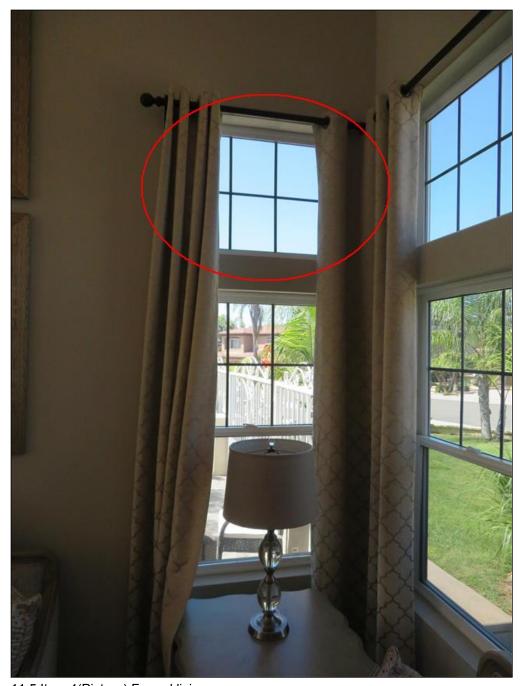
(1) Fogged windows indicate a failure of the energy efficiency of the window system; we recommend replacement. We identify all fogged windows that are readily visible during our inspection; however due to owner property and lighting conditions we may not be able to identify all defective conditions. Several window makers have extended warranties on failed window sills; we recommend further inquiry.

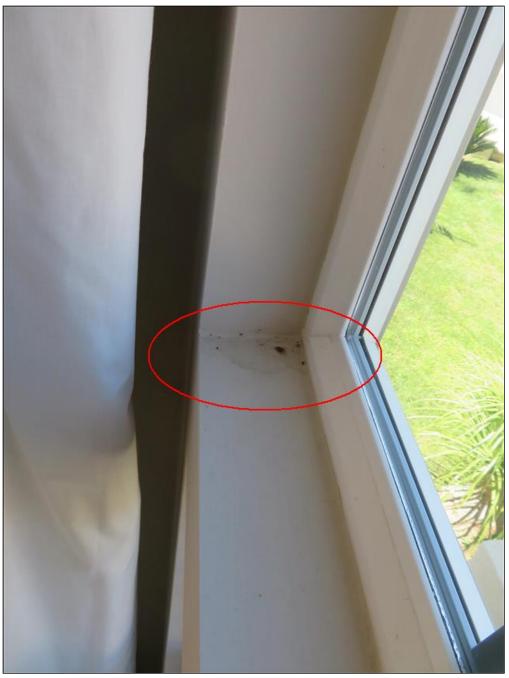
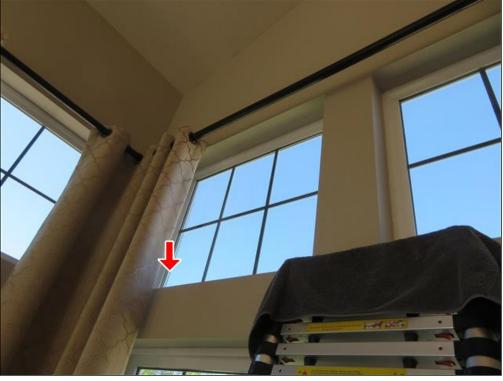
(2) Moisture staining observed at the formal living room window sill; this indicates a possible defective sill; we recommend further evaluation and corrections by a licensed window contractor.

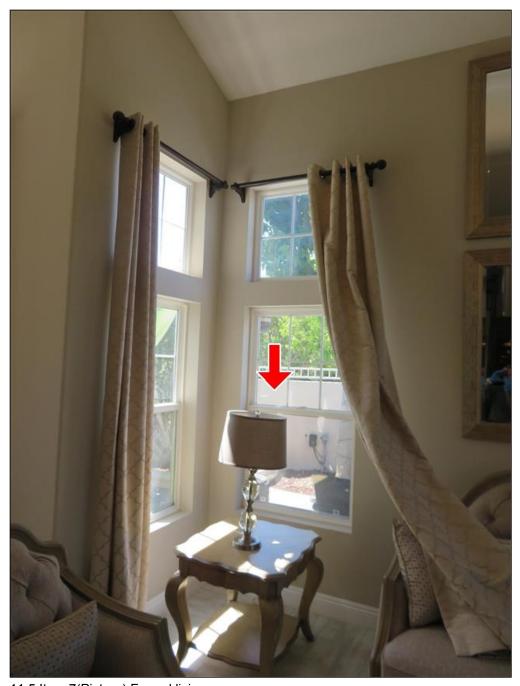
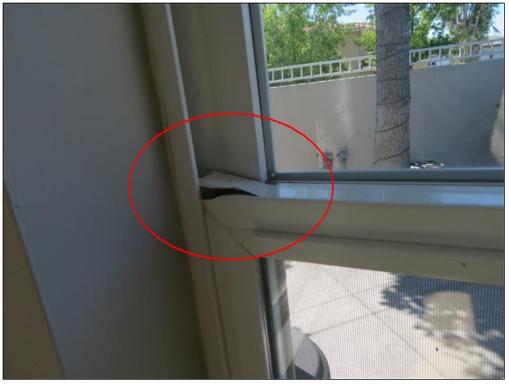
(3) Broken sash is a defect when a window will not remain in the open position, and can result in the window free falling to the sill; we recommend correction for safety.

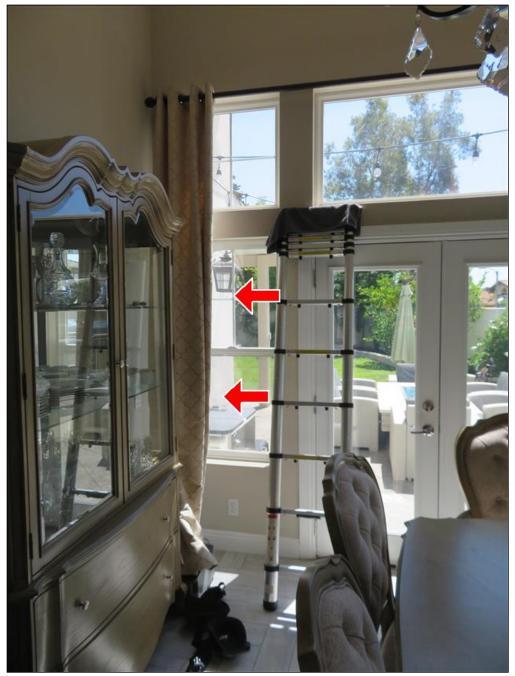
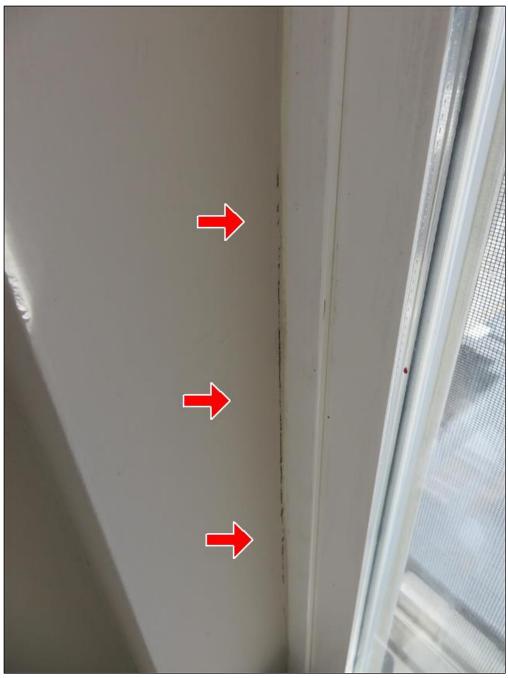
(4) Caulking deterioration observed at the dining room window; we recommend servicing.

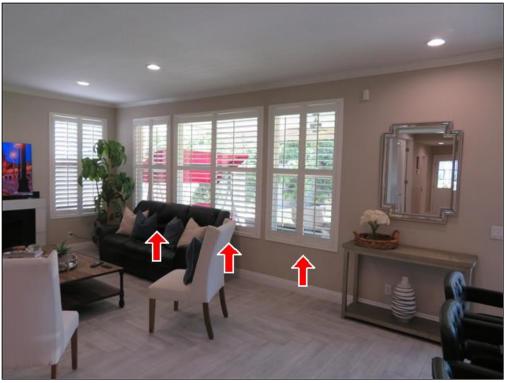
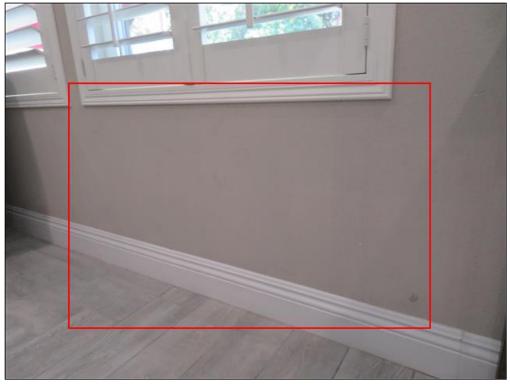
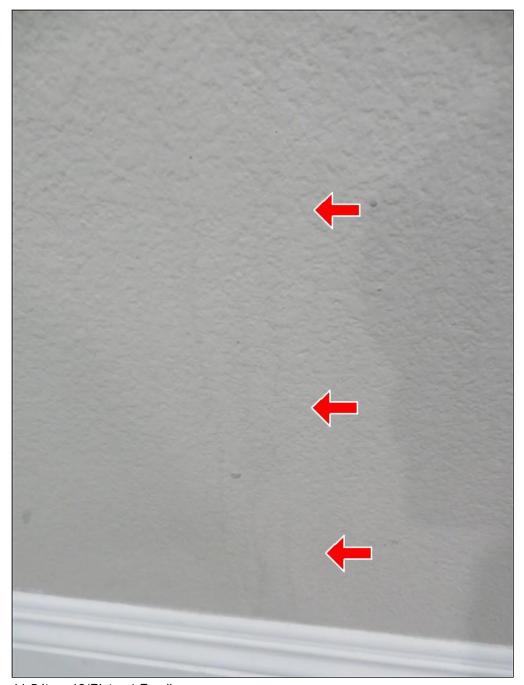
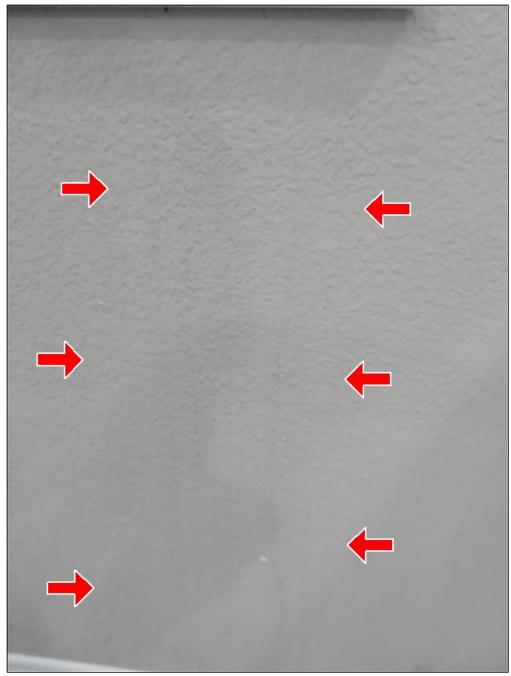
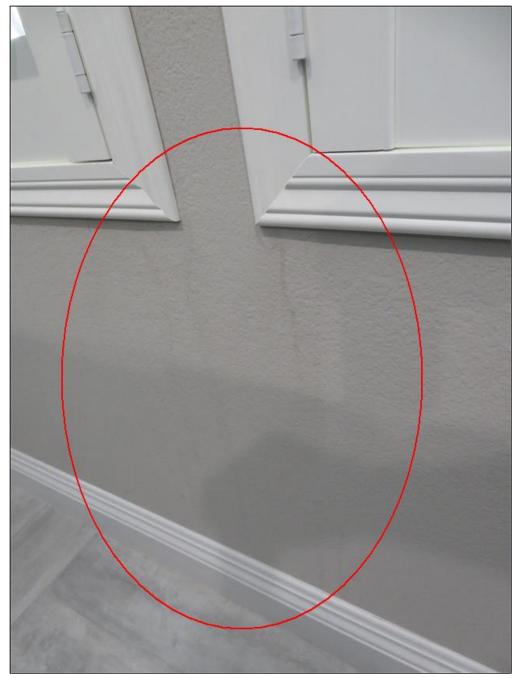
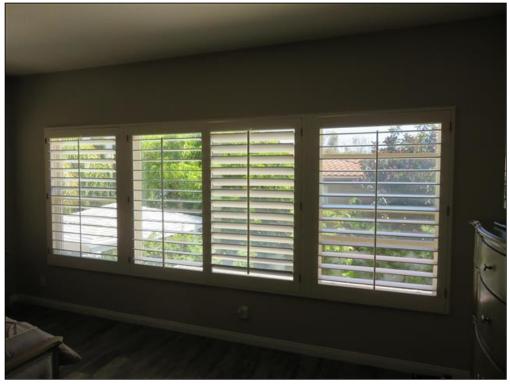
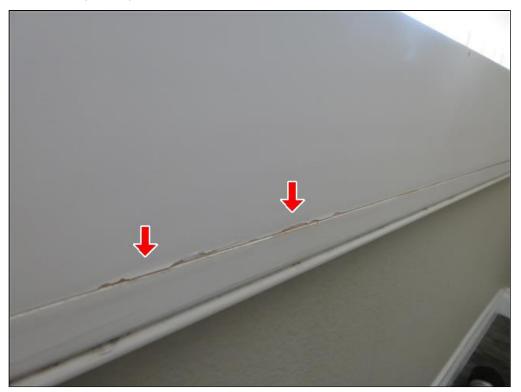
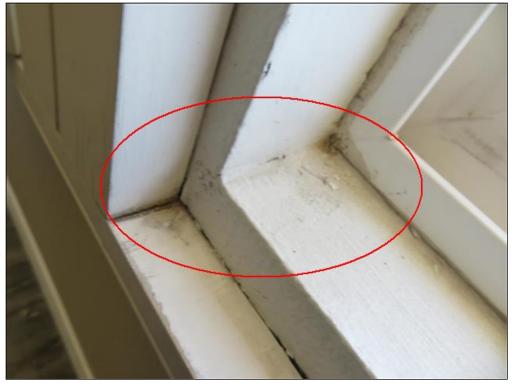
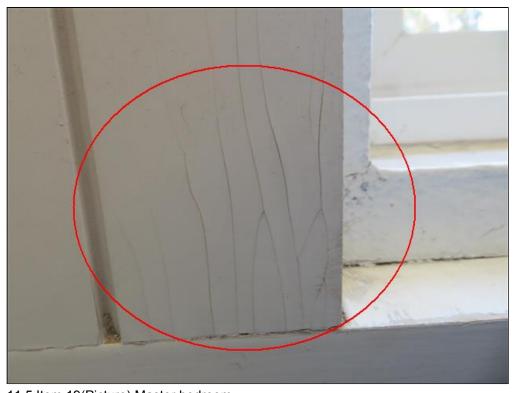
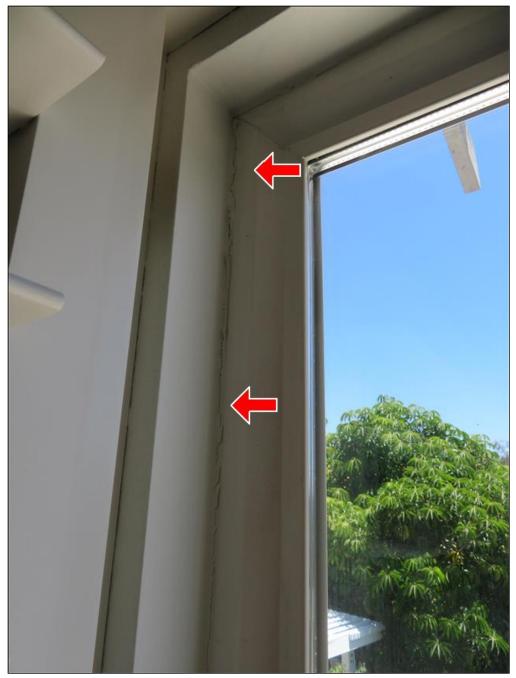
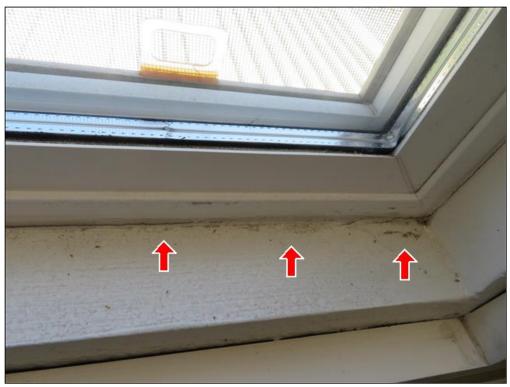
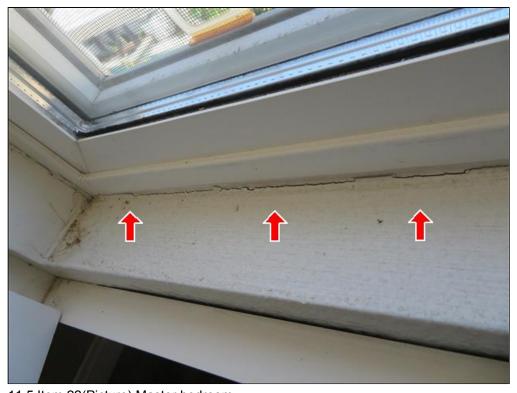
(5) Moisture intrusion at sills at the family room and master bedroom, this is an indication of leakage, we recommend leak testing of the windows and repairs as needed by a licensed window contractor.

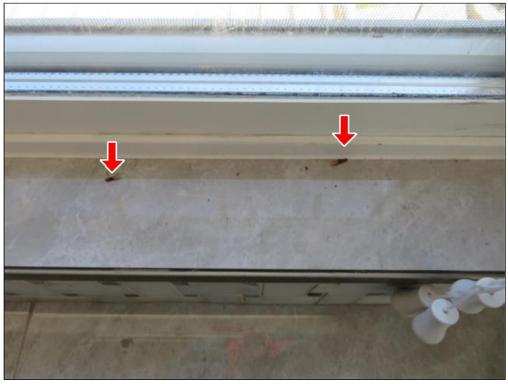
12.1 Item 1(Picture) Master bathroom.

Possible termites observed at the master bathroom window sill; we recommend further evaluation by a termite professional.

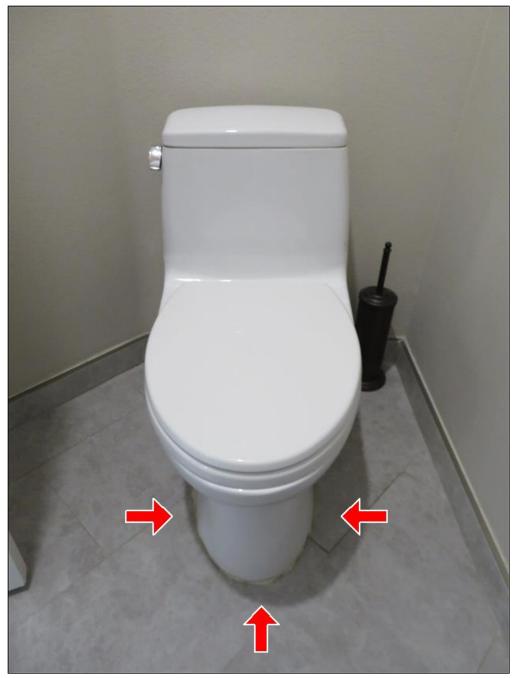
12.6 Item 1(Picture) Master bathroom.

(2) Lacks caulking: at the master bathroom; we recommend servicing.

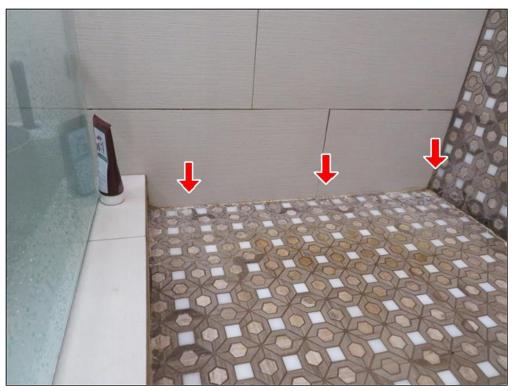
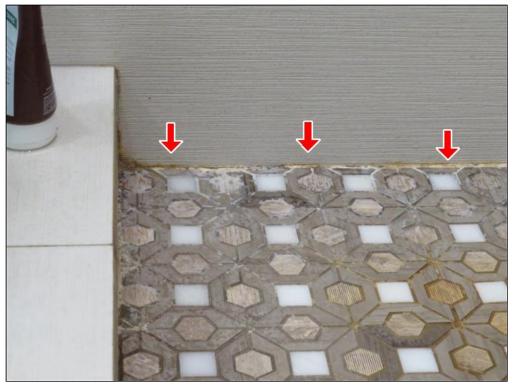
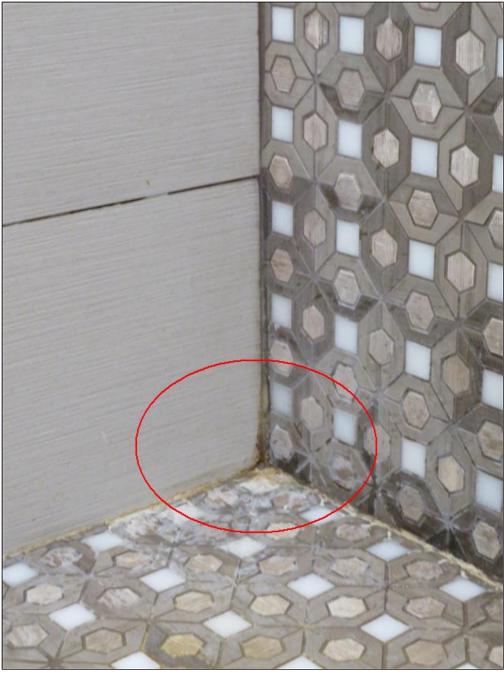
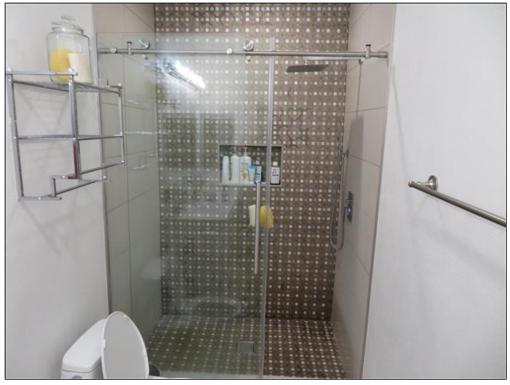
Caulking deterioration observed at the upper hallway bathroom shower enclosure; this condition can result in water seeping between the shower surface and liner and can result in mold growth; we recommend re-caulking.

12.8 Item 1(Picture) Upper hallway bathroom.

12.8 Item 2(Picture) Upper hallway bathroom.

12.8 Item 3(Picture) Upper hallway bathroom.

12.8 Item 4(Picture) Upper hallway bathroom.
